Evaluation of CuNiFer 10 Biofouling Resistance

Mark Bushnell, CoastalObsTechServices LLC

July, 2018

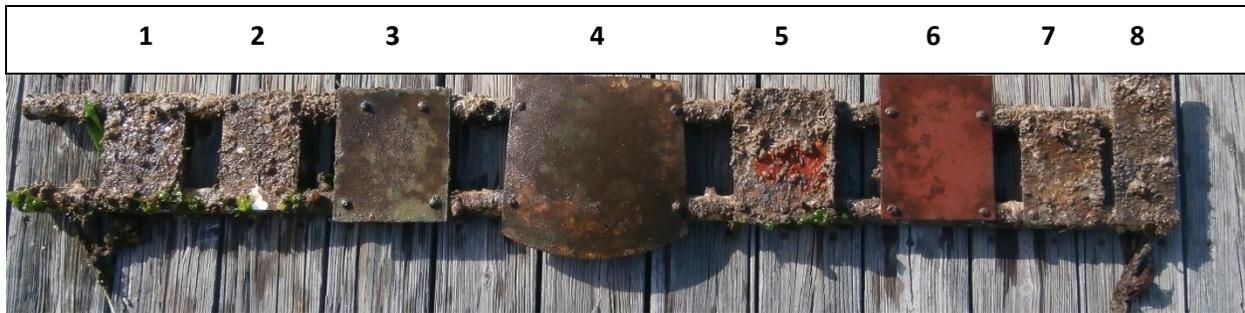
Figure 3 - The eight plates show a variety of fouling conditions when recovered after six months.

- 1) The untreated aluminum plate retained strongly adhered barnacles up to .9 inches in diameter.
- 2) The ClearSignal plate showed that most bio-fouling did indeed easily wash away, and remaining barnacles were easily removed. Water entering where the holes had been drilled had migrated under the ClearSignal coating over about one third of the plate. The coating remained in place and provided an easily cleaned surface, but the aluminum surface underneath was oxidized.

- 3) The plate coated with copper tape had a thin layer of slime which washed off easily. There was not much change before and after cleaning because there was so little fouling.

- 4) The Cunifer10 plate also had a thin layer of slime which was easily washed off. There was little effect by cleaning since there was no growth to wash off.

- 5) The untreated stainless steel control plate retained strongly adhered barnacles up to .9 inches in diameter.
- 6) The fiberglass plate painted with red Trinidad 75 also exhibited a thin layer of slime which was easily washed away, and again there was not much change after cleaning because there was so little fouling.

- 7) The aluminum plate coated with Desitin retained very little evidence of any remaining Desitin, and the bio-fouling extent was equal to the untreated control. After reviewing the weekly photographs, it appears that Desitin provided good protection for the first two months but thereafter offered no fouling resistance.
- 8) The Aerokret coating accumulated bio-fouling equal to the untreated control panels, but the fouling did indeed easily wash away and remaining barnacles were easily removed. The coating also remained intact with no loss of adhesion or any sign of oxidation of the underlying substrate.

None of the treated plates were treated on both sides, so that comparison of the individual plate material itself could be examined. Only the Cunifer 10 plate exhibited resistance on both sides, which was to be expected. All other untreated aluminum, stainless steel, and fiberglass plates fouled at equivalent levels, as did the PVC pipe frame.

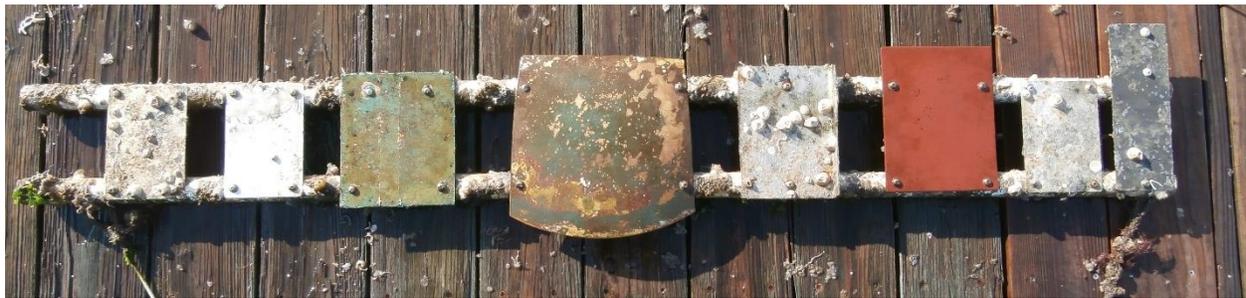
Figure 4 - The eight plates are shown after uniformly cleaning each with a directed jet of water.

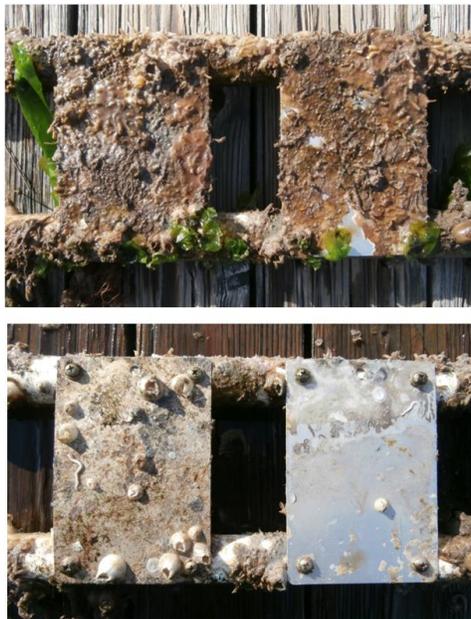
Figure 5 - The untreated aluminum control panel (left) and the ClearSignal panel (right) are shown before (top) and after (bottom) cleaning. The ClearSignal panel was easily cleaned, but the upper 1/3 of the panel exhibited coating separation.
