Evaluation of CuNiFer 10 Biofouling Resistance

Mark Bushnell, CoastalObsTechServices LLC

July, 2018

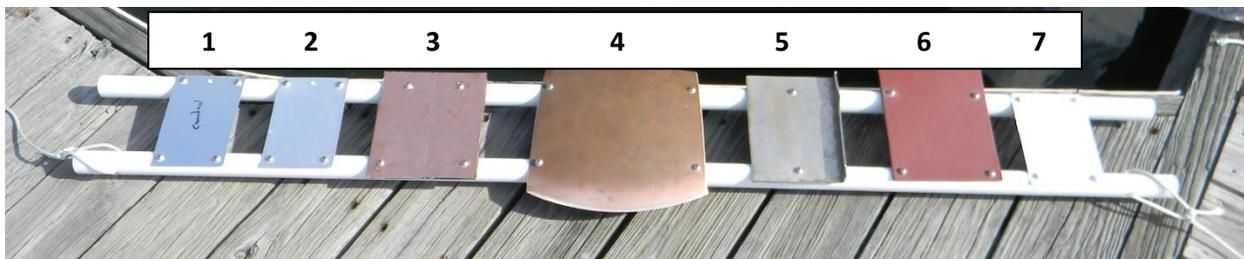
Figure 1 - Initial deployment of a variety of panels used to investigate anti-biofouling properties. For reference, the overall length of the PVC pipe is 1.5 meters

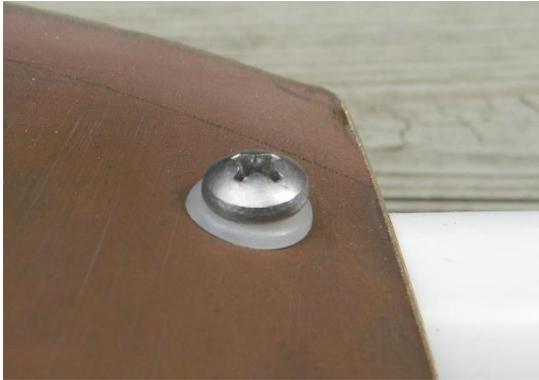
Figure 2 - Nylon washers isolated the dissimilar metals of the stainless steel screws and the test plates
