Article

# A Comparison of Beach Nourishment Methodology and Performance at Two Fringing Reef Beaches in Waikiki (Hawaii, USA) and Cadiz (SW Spain)

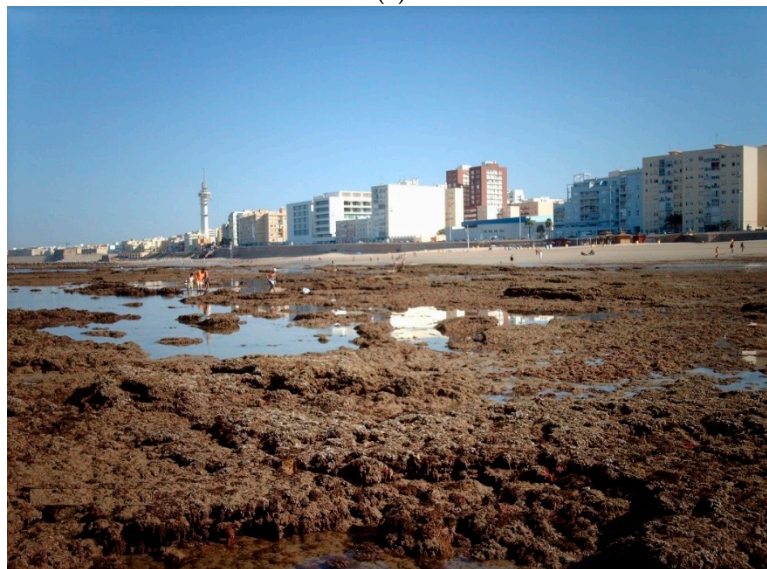
**Figure 2.** Location of Victoria Beach (VB) and indication of the borrow site (named Placer de Meca) in Cadiz, SW Spain, (a); and a ground view of the reef platform (b) (source: Muñoz-Perez, 2009).

RHB in Hawaii and VB in Cadiz, SW Spain, are both supported by calcareous reef platforms (Figures 1 and 2, respectively). Beaches on both of these coasts have experienced significant long-term erosion, which is problematic for the nationally important tourism industries that they support. Erosional trends are expected to accelerate with sea level rise [23], which is currently about 6 mm/year in Hawaii [24], and 2–3 mm/year in Cadiz. The costs of adaptation strategies (including beach nourishment) are already being considered [25].

A final key difference is that while both beaches have their toes supported by a reef platform, VB also has a fault scarp along its entire front and lacks the offshore channel which characterizes RHB. At RHB, this offshore channel is thought to be an important conduit for cross-shore sediment transport [22], a topic also mentioned by other researchers [28].

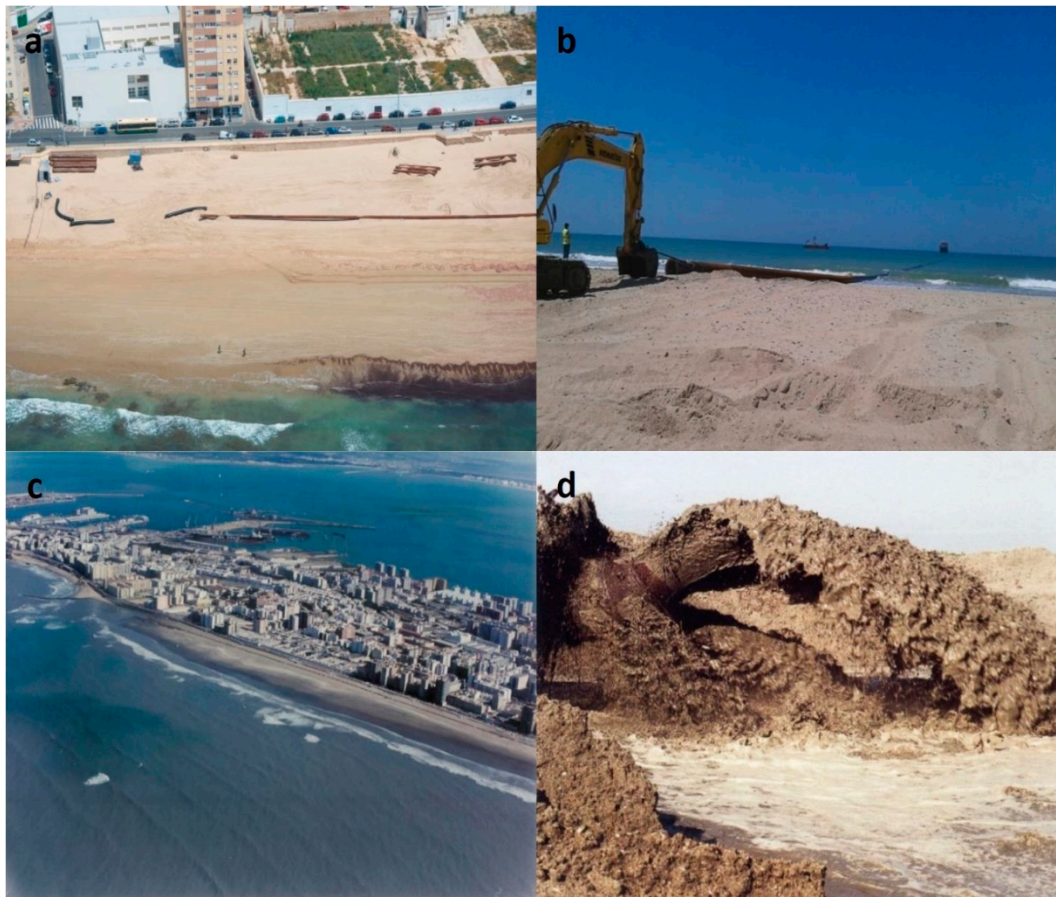
**Figure 4.** Different aspects of the sediment pouring on Victoria Beach, showing (a) pipe assembly; (b) transport of the pipe to the sea; (c) aerial view of the pipe while pouring; and (d) pipe outlet onto the beach.

In contrast, sand was pumped directly onto the dry beach at VB (i.e., the zone from high tide level to the landward edge). A volume of 260,000 m<sup>3</sup> was extracted from a borrow site called Placer de Meca, located 42 km (23 nm) from VB, close to the Cape of Trafalgar (Figure 2), using a trailing suction hopper dredger (TSHD). The dredger extracted the sand from a depth of ~20 m, and the complete process (mining, going to the beach, delivery, and returning to the borrow site) took about 8 h. Some pictures showing different aspects of the sediment pouring are shown in Figure 4.
