## PERFORMANCE VERIFICATION STATEMENT for Campbell Scientific CS547A and OBS-3A Salinity Probes

<b>TECHNOLOGY TYPE:</b>	Coupled conductivity and temperature sensors with instrument based algorithms for estimation of salinity
<b>APPLICATION:</b>	In situ estimates of salinity for coastal moored and profiled deployments
<b>PARAMETERS EVALUATED:</b>	Response linearity, accuracy, precision and reliability
<b>TYPE OF EVALUATION:</b>	Laboratory and Field Performance Verification
<b>DATE OF EVALUATION:</b>	Testing conducted from May through October 2008
<b>EVALUATION PERSONNEL:</b>	S. Gilbert, K. Gundersen, T. Johengen, T. McKissack, M. McIntyre, A. Pinchuk, H. Purcell, C. Robertson, D. Schar, G.J. Smith, M. Tamburri and D. Wells.

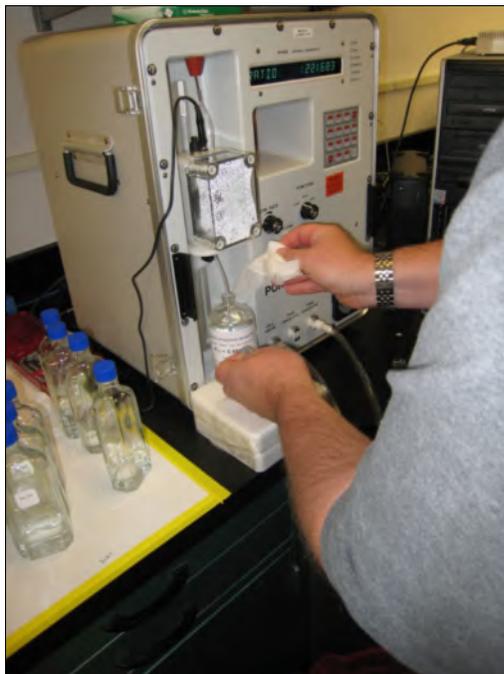
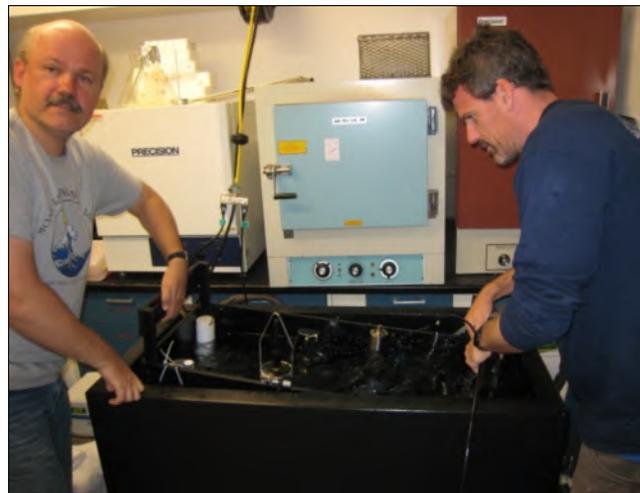
**Figure 1.** Analytical instrumentation (Portasal 8410A) used for laboratory analysis of salinity reference samples and one of the test baths and instrument racks used for the laboratory tests.

Laboratory tests focused on verifying the manufacturers' stated performance characteristics of accuracy and precision using controlled laboratory settings to obtain the highest degree of accuracy and precision for corresponding reference standards. The instrument package was tested at five different salinity levels including 35, 30, 25, 16 and 6 on the practical salinity scale (PSS-78; 60 to 6 mS/cm conductivity), each at three different temperatures including 32 °C, 16 °C and 6 °C. The instrument was pre-equilibrated to the controlled bath test conditions for 60 minutes prior to the start of reference sampling. The instrument was set to measure in situ conductivity and temperature using its own algorithms to derive a practical salinity estimate from these values at 1-minute intervals. Ten reference water samples were collected at sensor depth into sealed pre-rinsed glass salinity bottles at 3 minute intervals over 30 minutes. Each reference sample set was stored at room temperature and analyzed after 24 hours on the Portasal 8410A (Fig. 1).

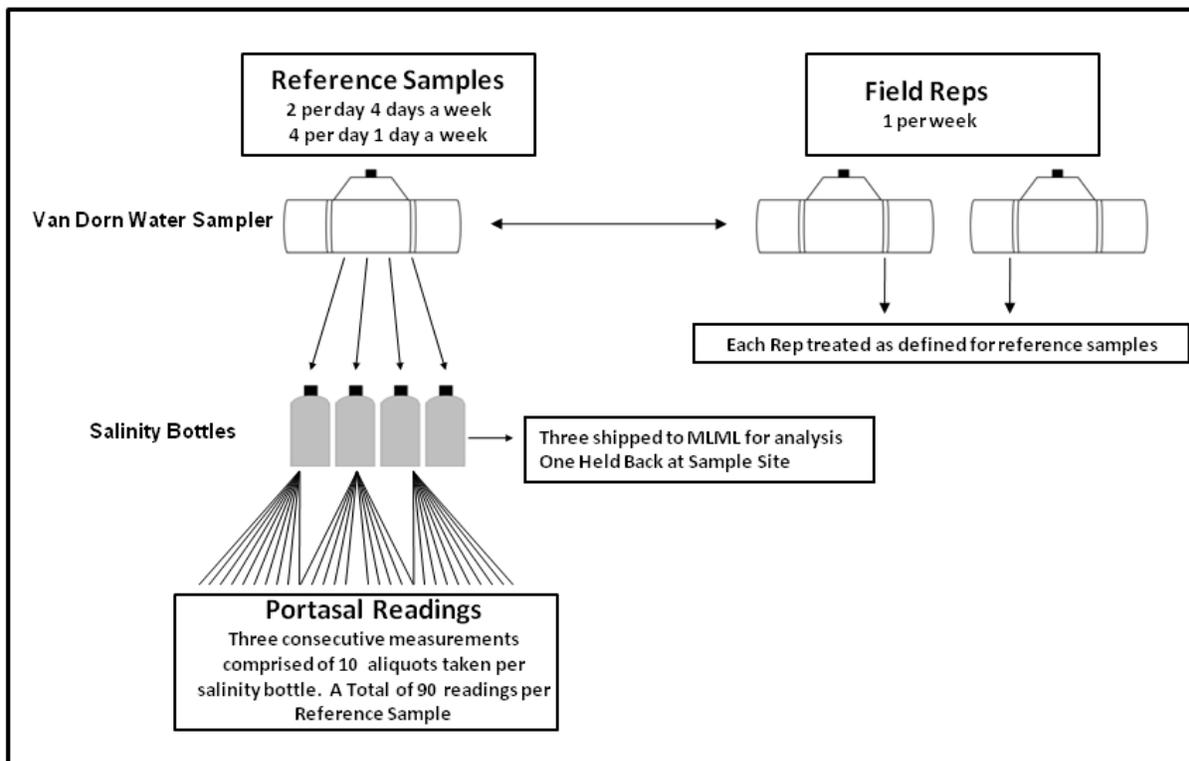
**Figure 2.** Schematic representation of the reference sampling process conducted during moored deployment field tests.

As part of each field test, the instrument package was also tested in well-mixed tanks filled with ambient site water immediately before and after the moored deployment. The post-deployment tank test occurred after the instrument was thoroughly cleaned to remove all visible traces of biofouling. The purpose of the tank test was to help differentiate the effects of biofouling from those of instrument drift that may have occurred during the deployment. The instrument was equilibrated to the tank conditions for at least 30 minutes prior to sampling and programmed to sample at 1 minute intervals. Three reference samples were collected and each sub-sampled into triplicate salinity bottles during the instrument sampling interval for comparison.

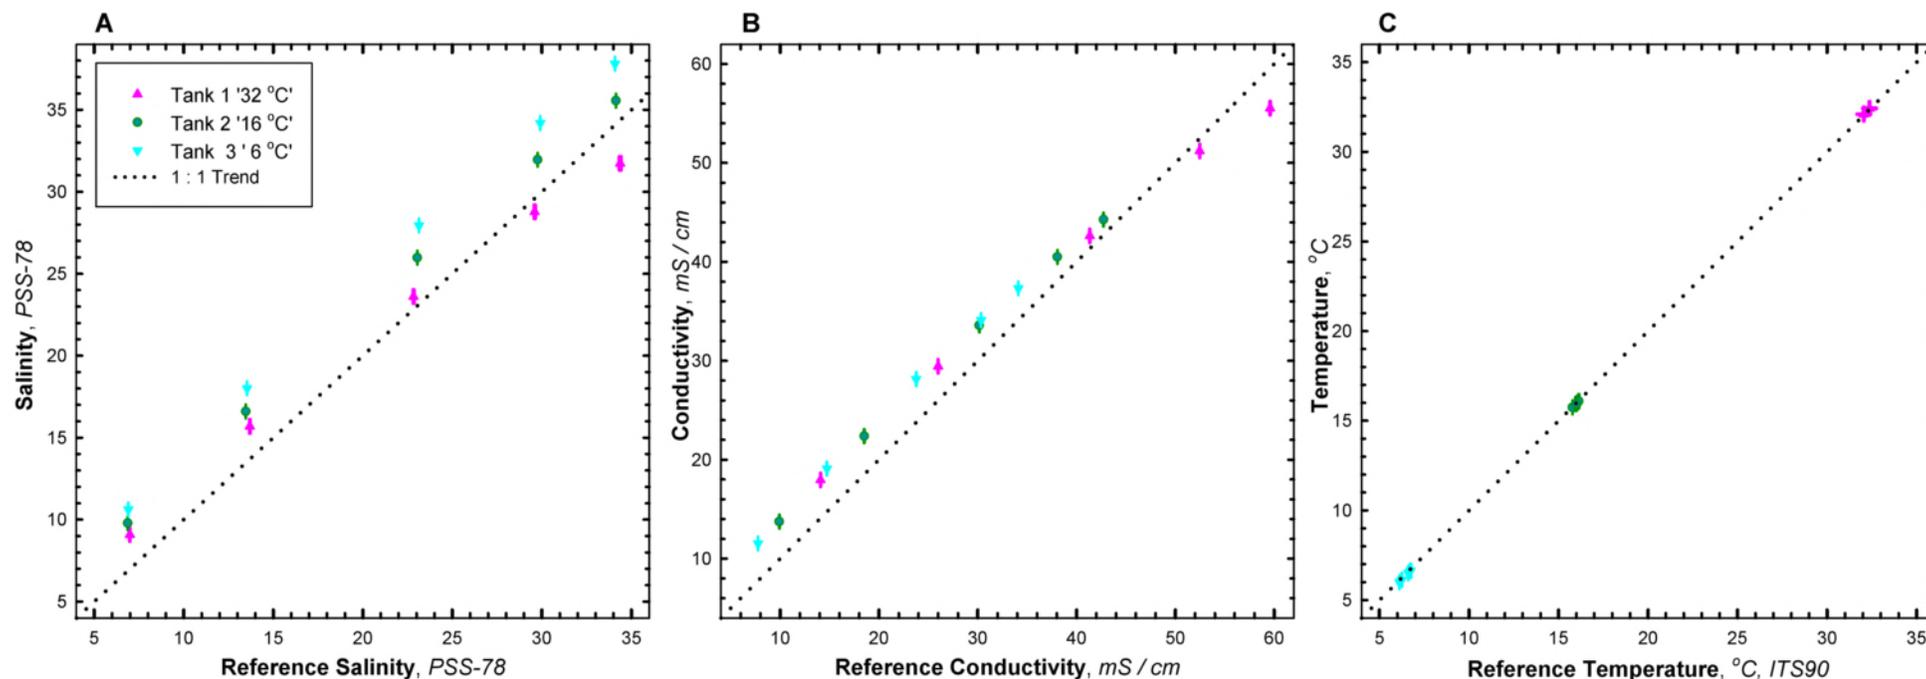
**Figure 3.** Evaluation of the response linearity for Campbell Scientific's model CR800 conductivity and temperature sensor package during controlled laboratory exposures to a combination of natural seawater dilutions and temperatures. Consecutive test exposures ranged between 35 to 6 on the practical salinity scale (PSS-78; 60 to 6 mS/cm conductivity) and 33 to 6 °C. [A] Correspondence of instrument derived salinity to Portosal reference measurements; [B] Correspondence of instrument in situ conductivity measurement to conductivity estimate derived from the Portosal salinity and reference temperature measurement by inversion of the seawater equations of state (IAPSO PSS-78); [C] Correspondence of instrument temperature measurement to bath reference temperature recorded by a calibrated RBR 1060 logging thermometer. Data points are represented as mean  $\pm$  standard deviation of and 10 reference water samples. Dotted lines represent 1:1 ideal correlation of measures.

Analyzed across all five salinity levels and all three temperatures, the CS547A probe exhibited a linear response to the test solutions with an  $R^2 = 0.963$ , but with a relatively large standard error of 1.95 and a slope = 0.926 (Fig. 3). It appears that initial calibration factors or salinity algorithms were not sufficiently defined resulting in derived salinity to be influenced by test solution temperature. The temperature sensor response itself was extremely linear ( $R^2 > 0.9999$ ). The variance in 30 repeated measurements taken at one minute intervals for each of the laboratory trials is shown in Figure 4. The plots are not a measure of engineering precision as environmental conditions within the test baths did change during the sampling process. The variation in instrument derived measurements is plotted relative to the average standard deviation and 3-times the standard deviation upper specification limit of reference salinity, conductivity, and temperature measurements taken over corresponding time intervals for all lab tests. An alternative version of this figure showing a direct comparison of instrument versus reference sample variance for each individual trial is given in Appendix 1. Instrument offsets in salinity, conductivity and temperature were computed for each test run as the difference in the mean instrument measure from the mean reference measure for that test bath condition (Fig. 5). The response of the probe differed across test temperature as well as salinity level. The average of the measurement offsets over the 15 lab test conditions were 2.33 psu for salinity, 2.52 mS/cm for conductivity, and -0.0394 °C for temperature.

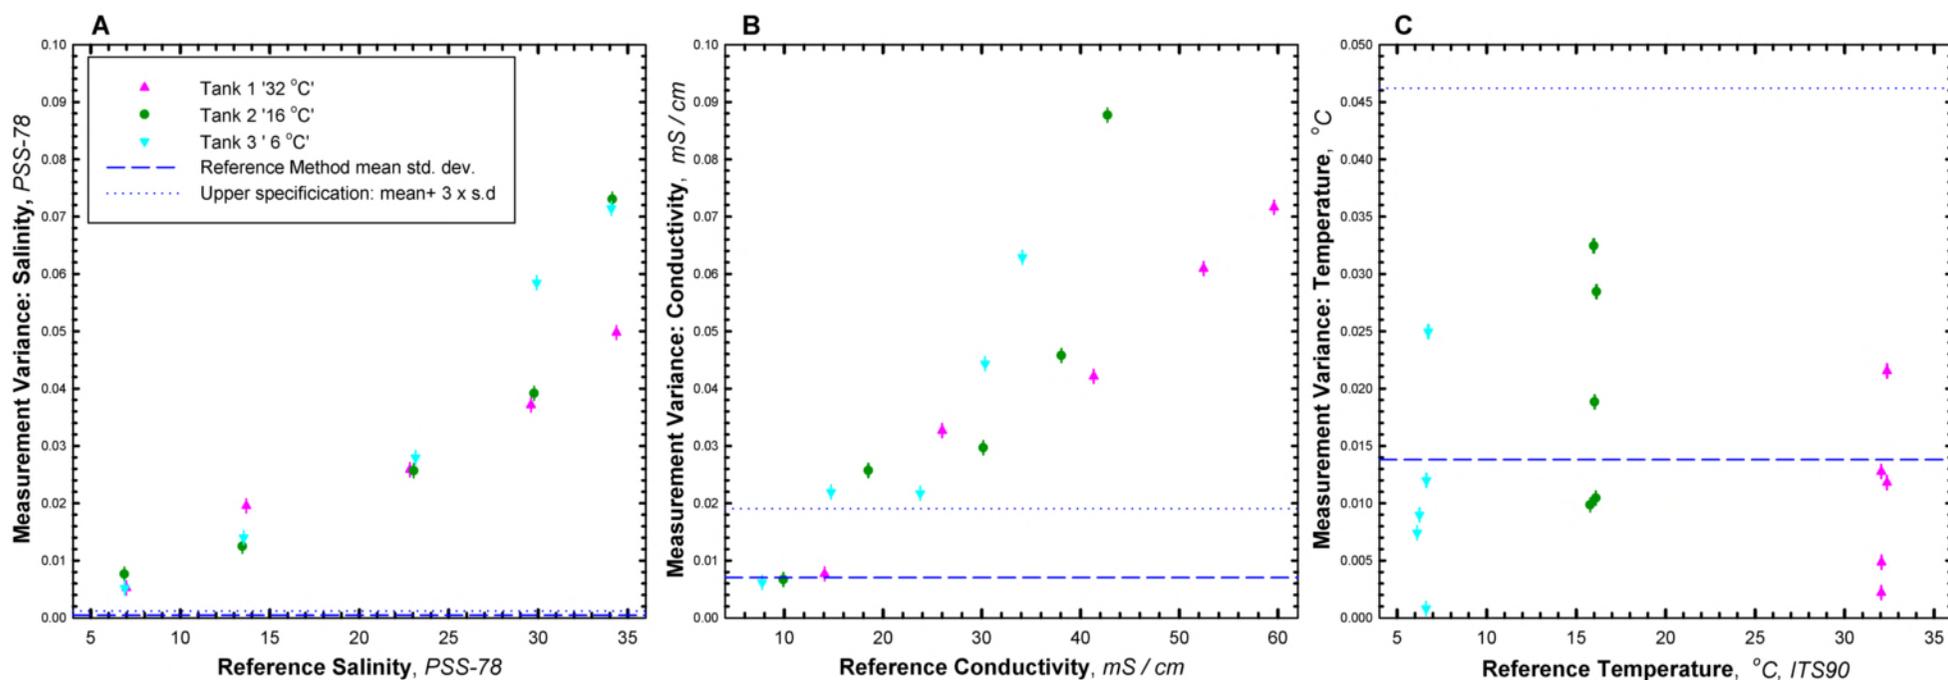
**Figure 4.** Evaluation of measurement variation of Campbell Scientific's model CR800 conductivity and temperature sensor package achieved during the laboratory exposure trials plotted in Fig. 3. Relative measurement variance is presented as the standard deviation from 30 consecutive instrument reads associated with each test exposure. The corresponding reference measurement variance range is provided in each plot as the mean standard deviation (dashed line) and 3x s.d. (dotted line) of consecutive reference samples, averaged across all trials. [A] Variance of derived salinity estimate; [B] Variance of in situ conductivity measurement; [C] Variance of instrument temperature measurement.

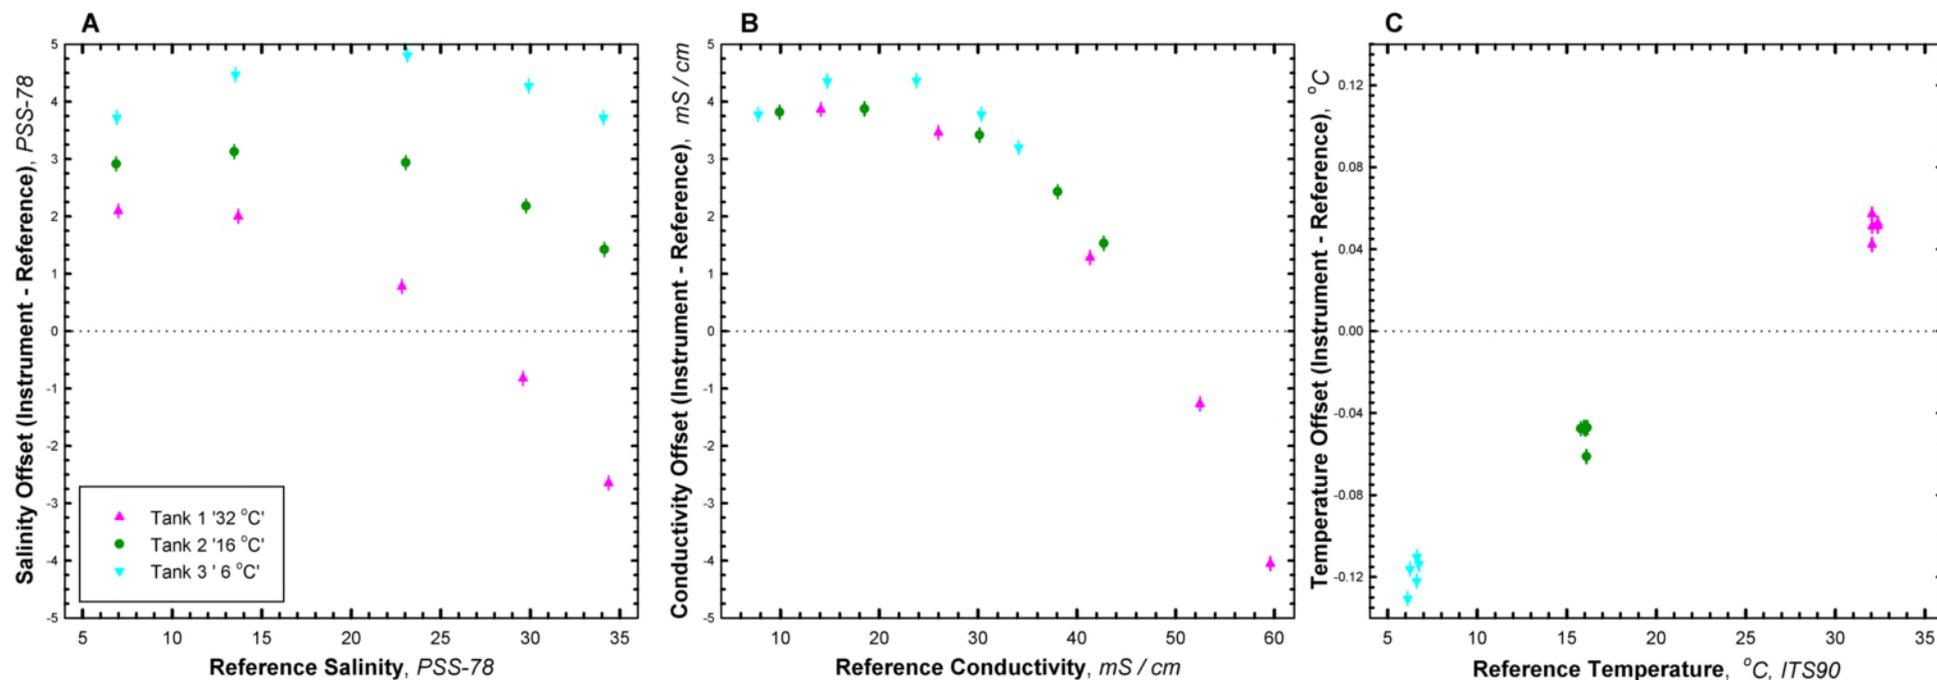
**Figure 5.** Evaluation of the relative accuracy of Campbell Scientific's model CR800 conductivity and temperature sensor package achieved during the laboratory exposure tests plotted in Fig. 3. Relative accuracy is estimated as the difference or offset between the mean instrument reading and mean reference reading for each exposure test. [A] Relative accuracy of derived salinity estimate; [B] Relative accuracy of instrument's in situ conductivity measurement; [C] Relative accuracy of instrument's temperature measurements. Dotted horizontal line represents no difference between instrument and reference method measurement.

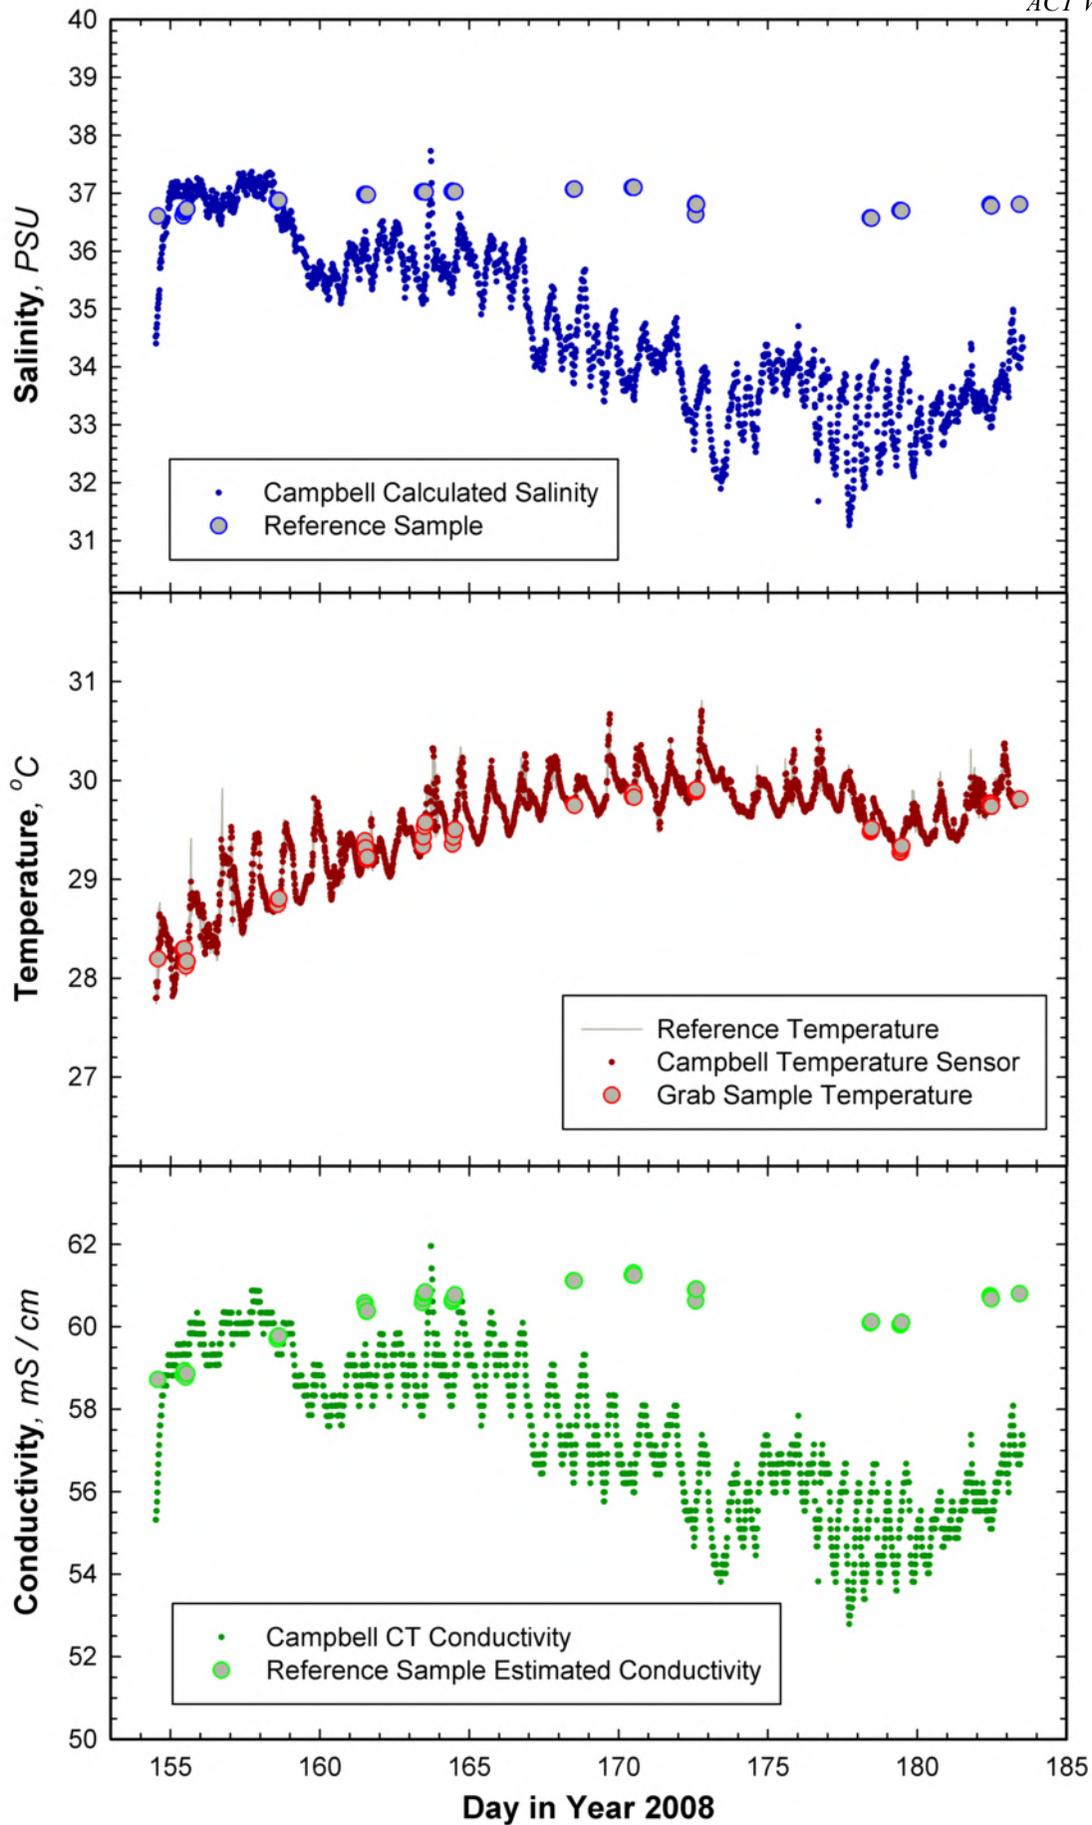
**Figure 7.** Time series of instrument measurements and corresponding reference samples acquired during USF field deployment.

Time series data of in situ measured conductivity and temperature, and derived salinity, for the FL field test were plotted against corresponding results from the laboratory analyzed reference samples and reference temperature logger (Fig. 7). After an initial low instrument reading the probe appeared to stabilize with an offset of around 0.4 psu, but then rapidly deteriorated, most likely from biofouling (Fig. 8). The error in instrument derived salinity was basically due to the performance of the conductivity sensor and the temperature sensor was stable throughout the deployment with an average offset of only  $0.0258 \pm 0.0157$  °C relative to the reference temperature logger. Results of the pre- and post-deployment exposure tests, after the instrument was cleaned to remove all biofouling, are shown in figure 9. There was a noticeable change in instrument response between the pre- and post-exposure tests with salinity offsets of 1.6 and 2.6 psu, respectively. The amount of biofouling that developed on the instrument during the deployment is shown in figure 10, and a time-series of biofouling rates on PVC tiles is shown in figure 11.

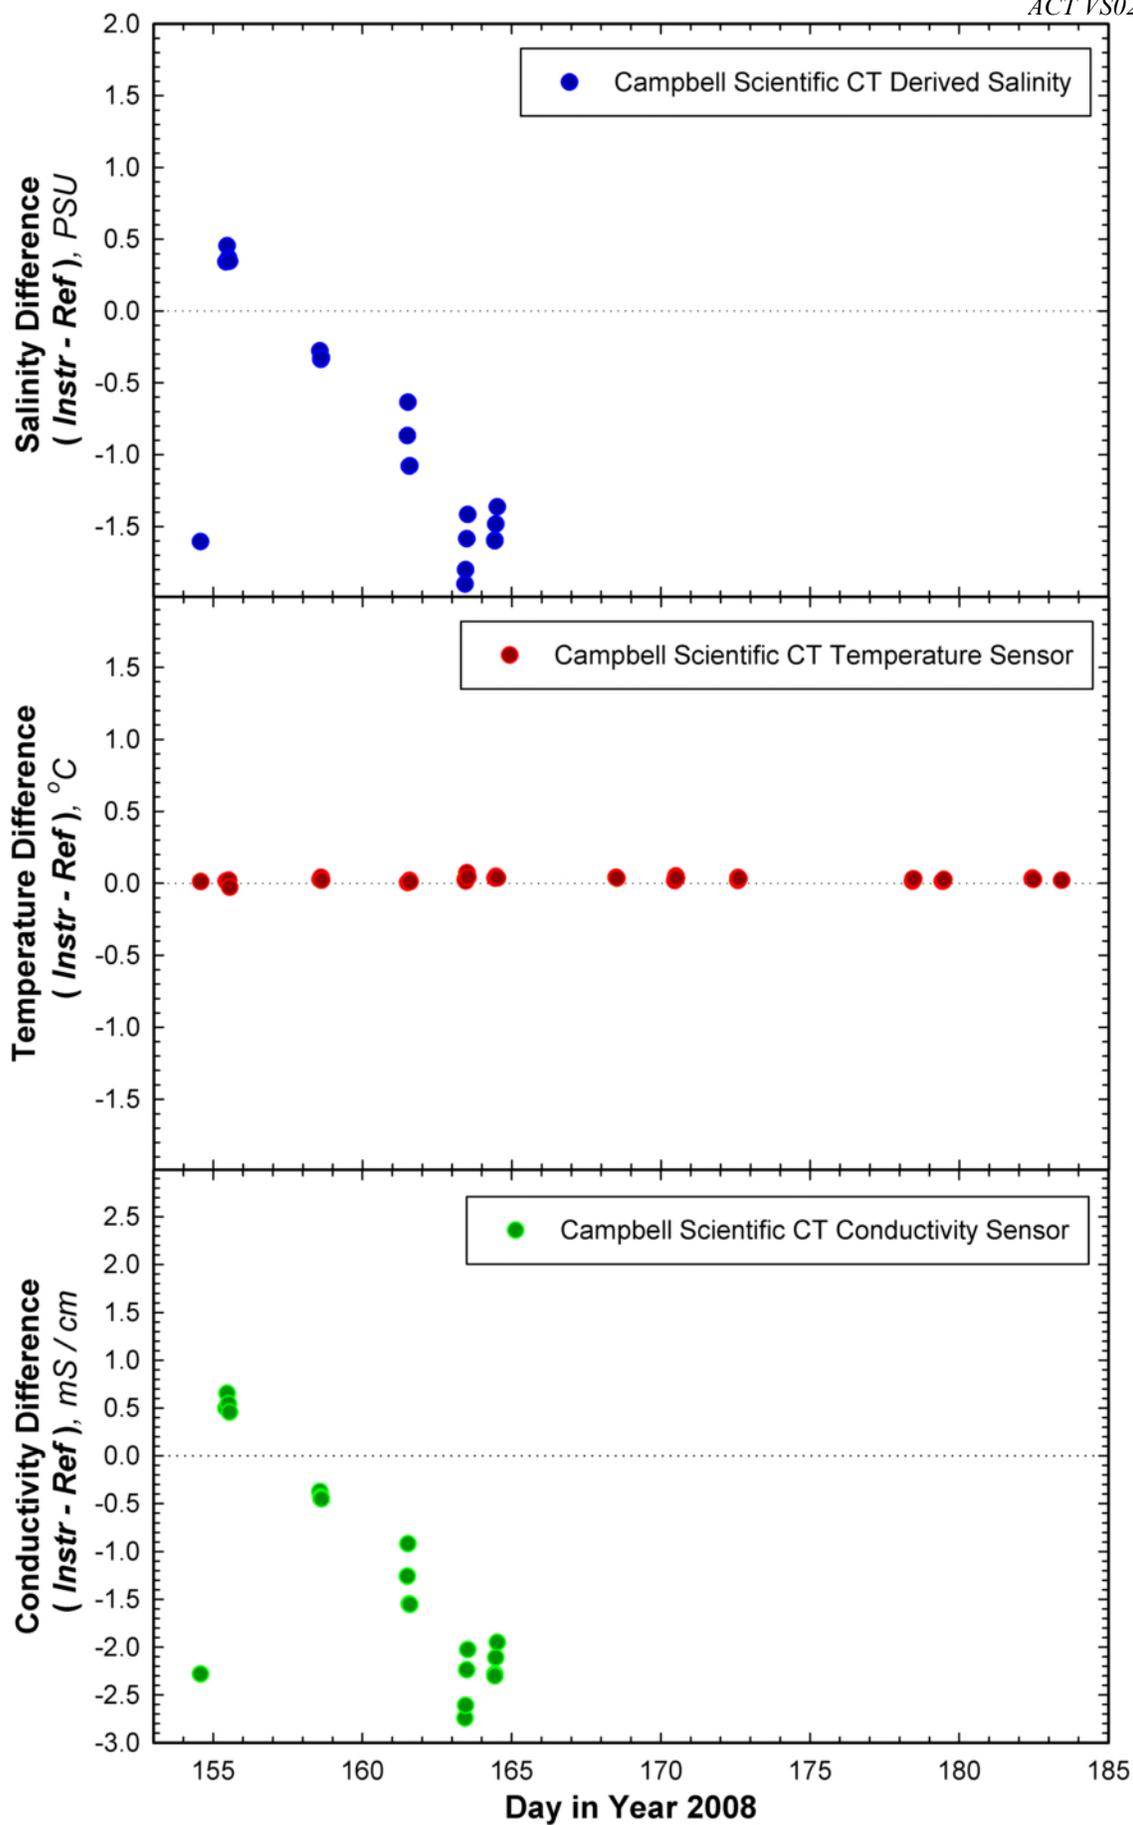
**Figure 8.** Assessment of relative accuracy of instrument time series measurements during USF field deployment.

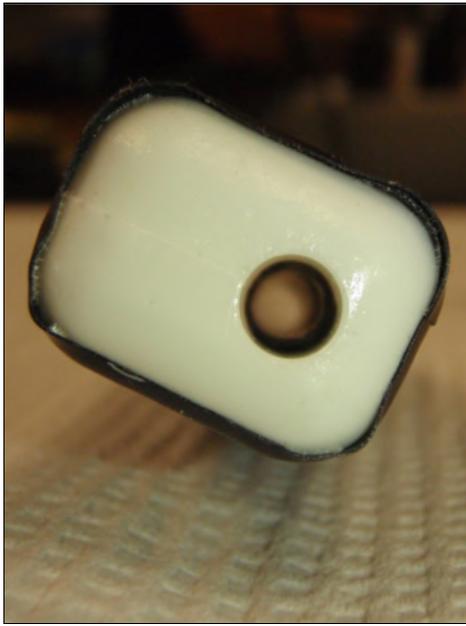
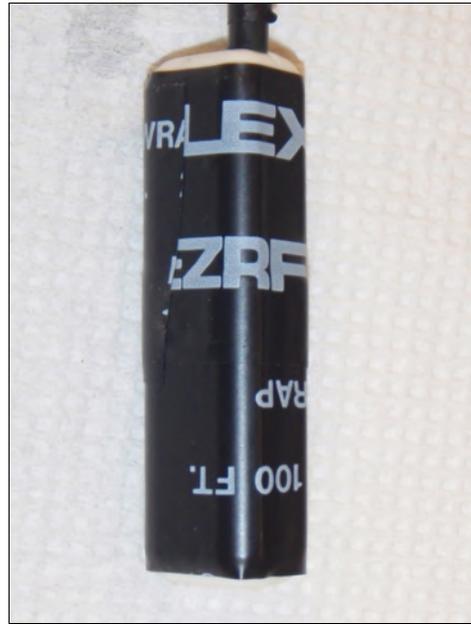
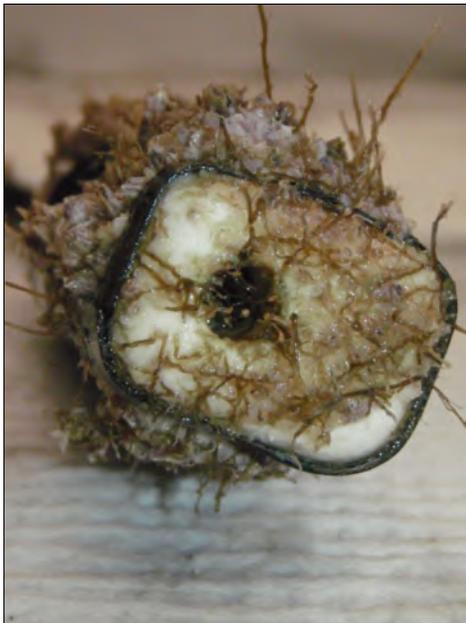
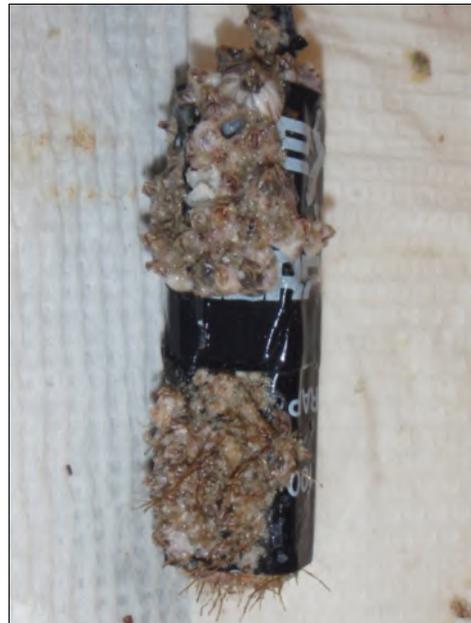
Before and after photos were taken of the instrument to examine the extent and possible impacts of bio-fouling (Fig. 10). A significant amount of hard, encrusting bio-fouling was evident across most of the instrument body by the end of the deployment, including directly within the conductivity cell.

Prior to Deployment (Close-up)

Prior to Deployment (Full View)

After Deployment (Close-up)

After Deployment (Full View)

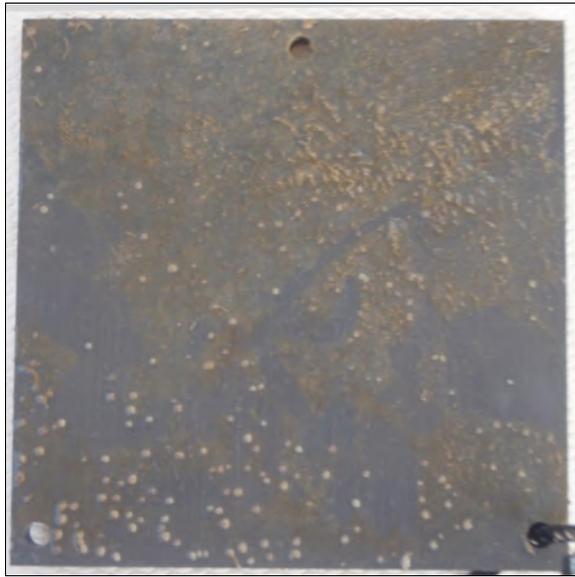
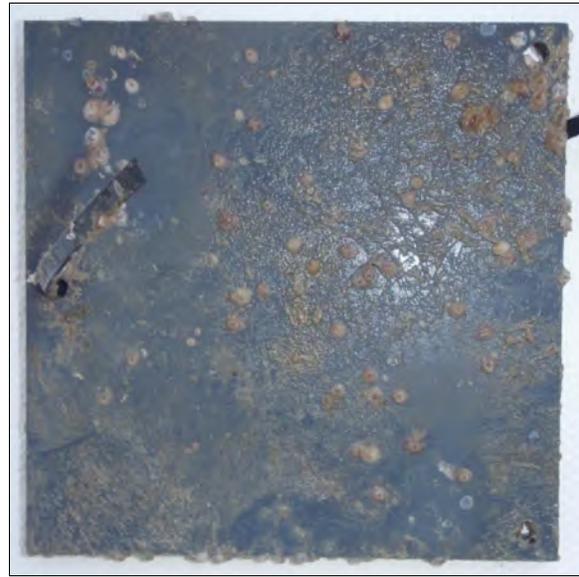
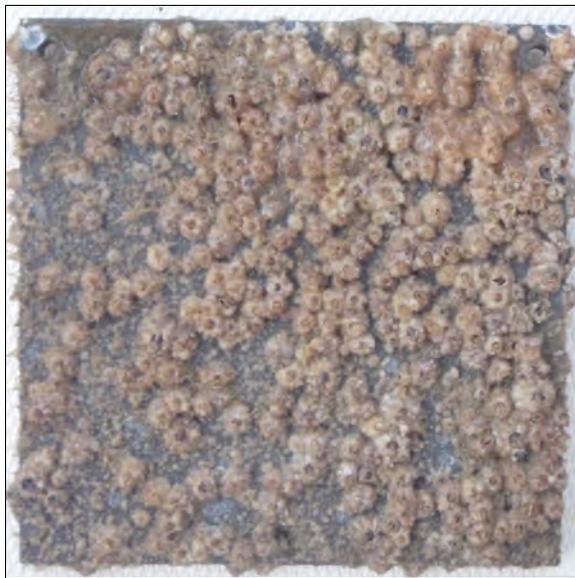
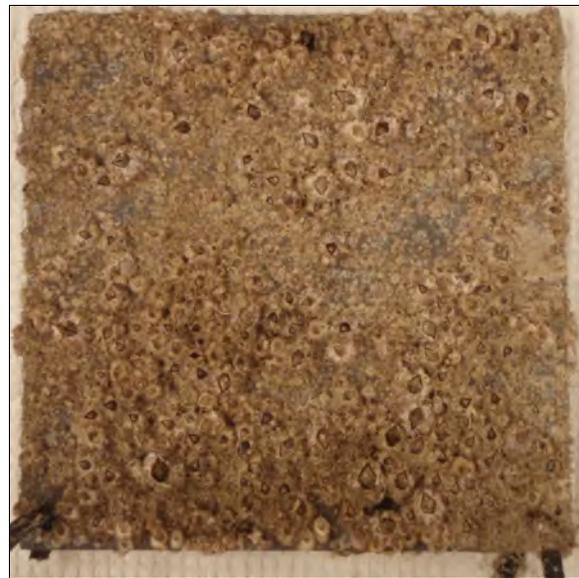
Bio-fouling plates were retrieved and photographed once each week throughout the deployment to help define the rate and extent of biofouling within the test environment (Fig. 11). By the third week of deployment there was an extensive amount of hard, encrusting biofouling at the Florida test site.

USF Site Week 1

USF Site Week 2

USF Site Week 3

USF Site Week 4

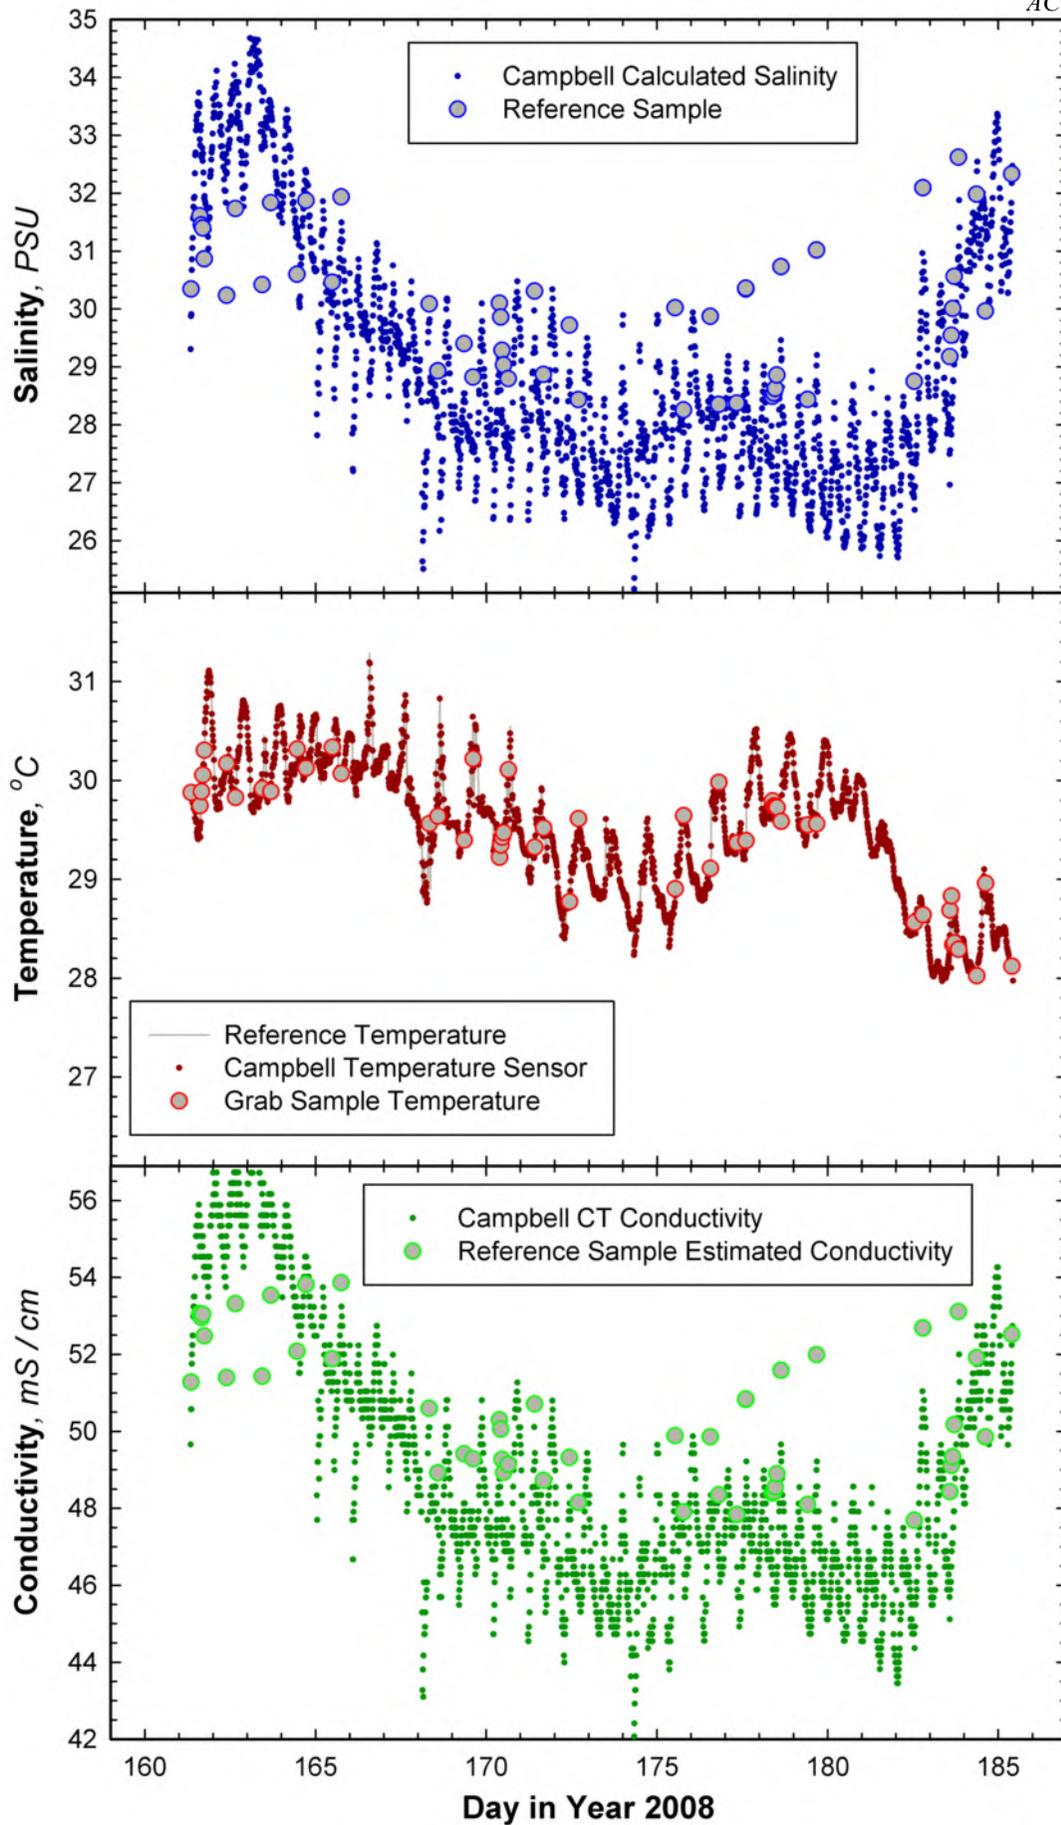
**Figure 13.** Time series of instrument measurements and corresponding reference samples acquired during the SkIO field deployment.

Time series data of in situ measured conductivity and temperature, and derived salinity, for the GA field test were plotted against corresponding results from the laboratory analyzed reference samples and reference temperature logger (Fig. 13). The sonde again showed an abrupt shift in response (from a negative to positive offset) after the first day but then showed a rapid decline as biofouling developed leading to significant negative offsets in salinity and conductivity measurements (Fig. 14). In contrast the temperature sensor was quite stable throughout the deployment with an average offset of  $-0.0090 \pm 0.0413$  °C relative to the reference temperature logger. Results of the pre- and post-deployment exposure tests, after the instrument was cleaned to remove all biofouling, are shown in figure 15. Only a single reference sample was obtained during the pre-test due to an operating error. The initial offset in the salinity measurement was less than 0.1 psu for the pre-exposure test; however, after the deployment the instrument had a positive offset of 3.6 psu. The temperature sensor response was very consistent between pre and post exposure tests as was seen in the time series data as well. The amount of biofouling that developed on the instrument during the deployment is shown in figure 16, and a time-series of biofouling rates on PVC tiles is shown in figure 17.

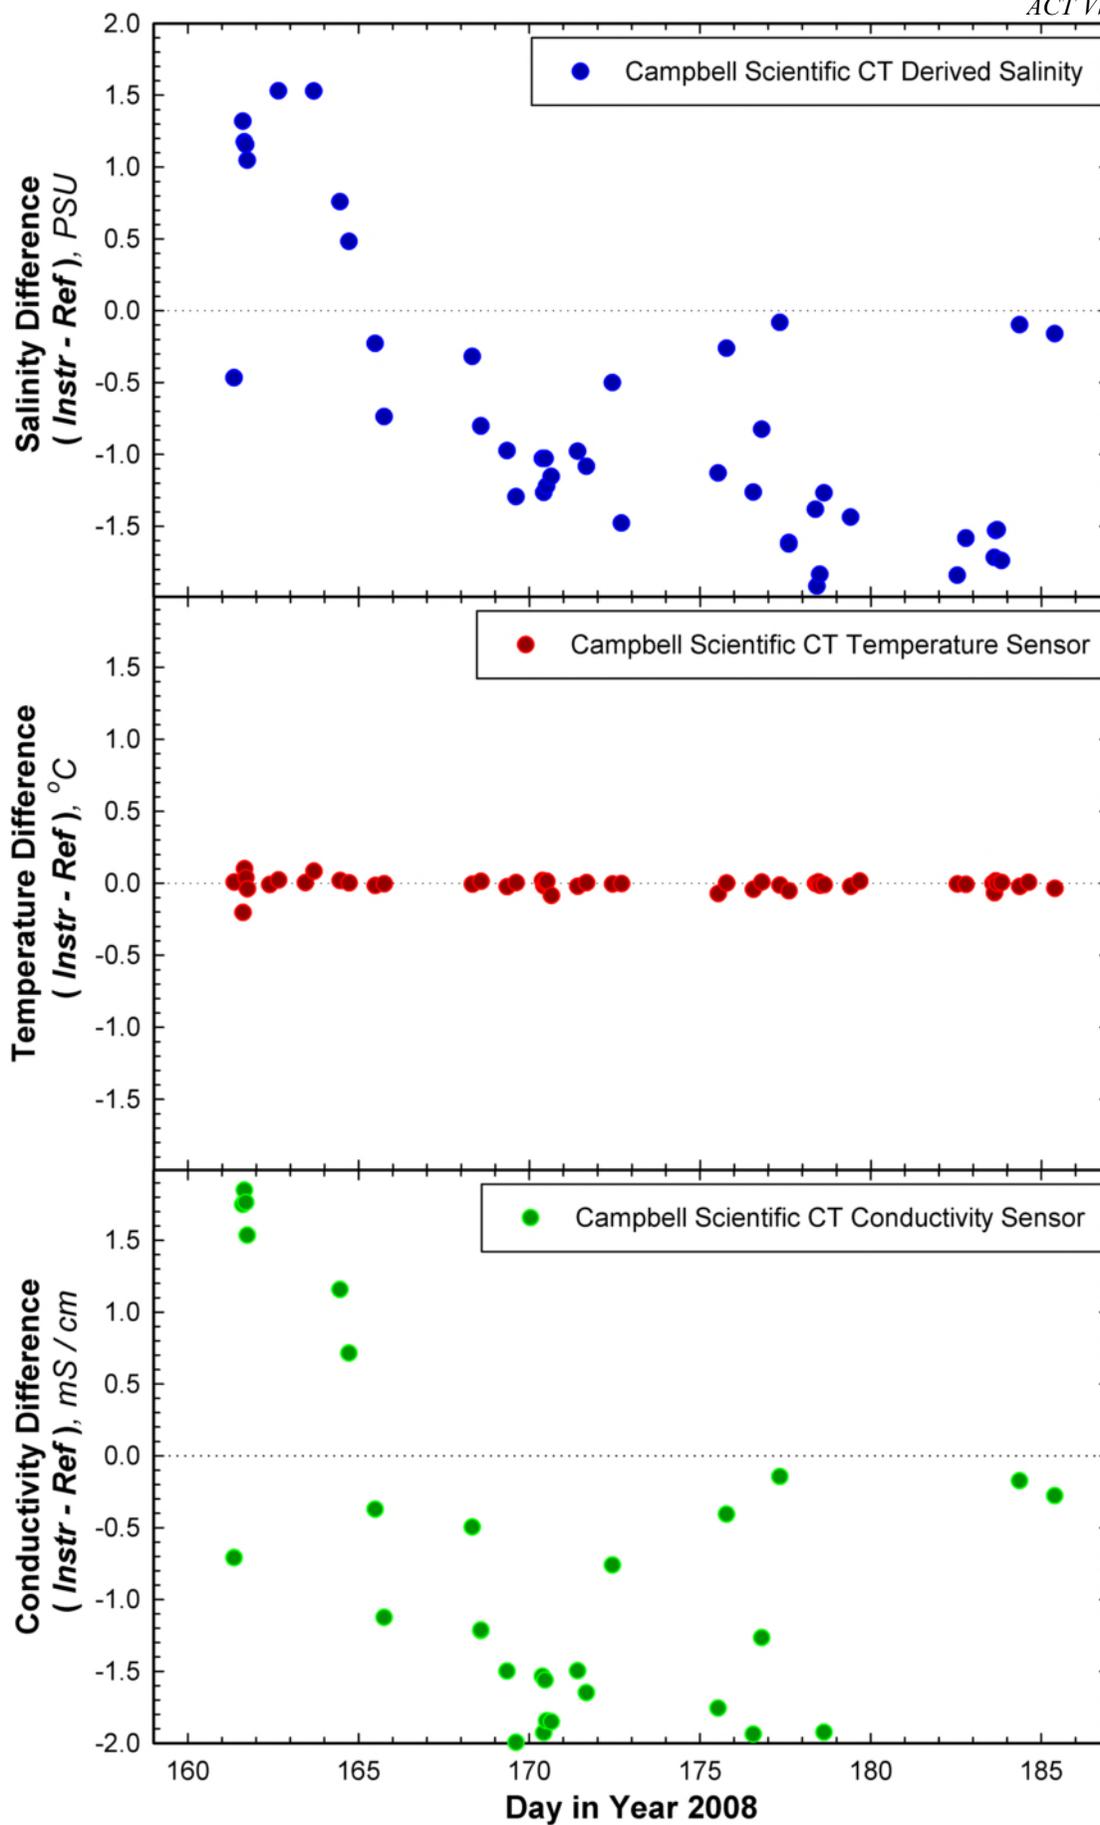
**Figure 14.** Assessment of relative accuracy of instrument time series measurements during the SKIO field deployment.

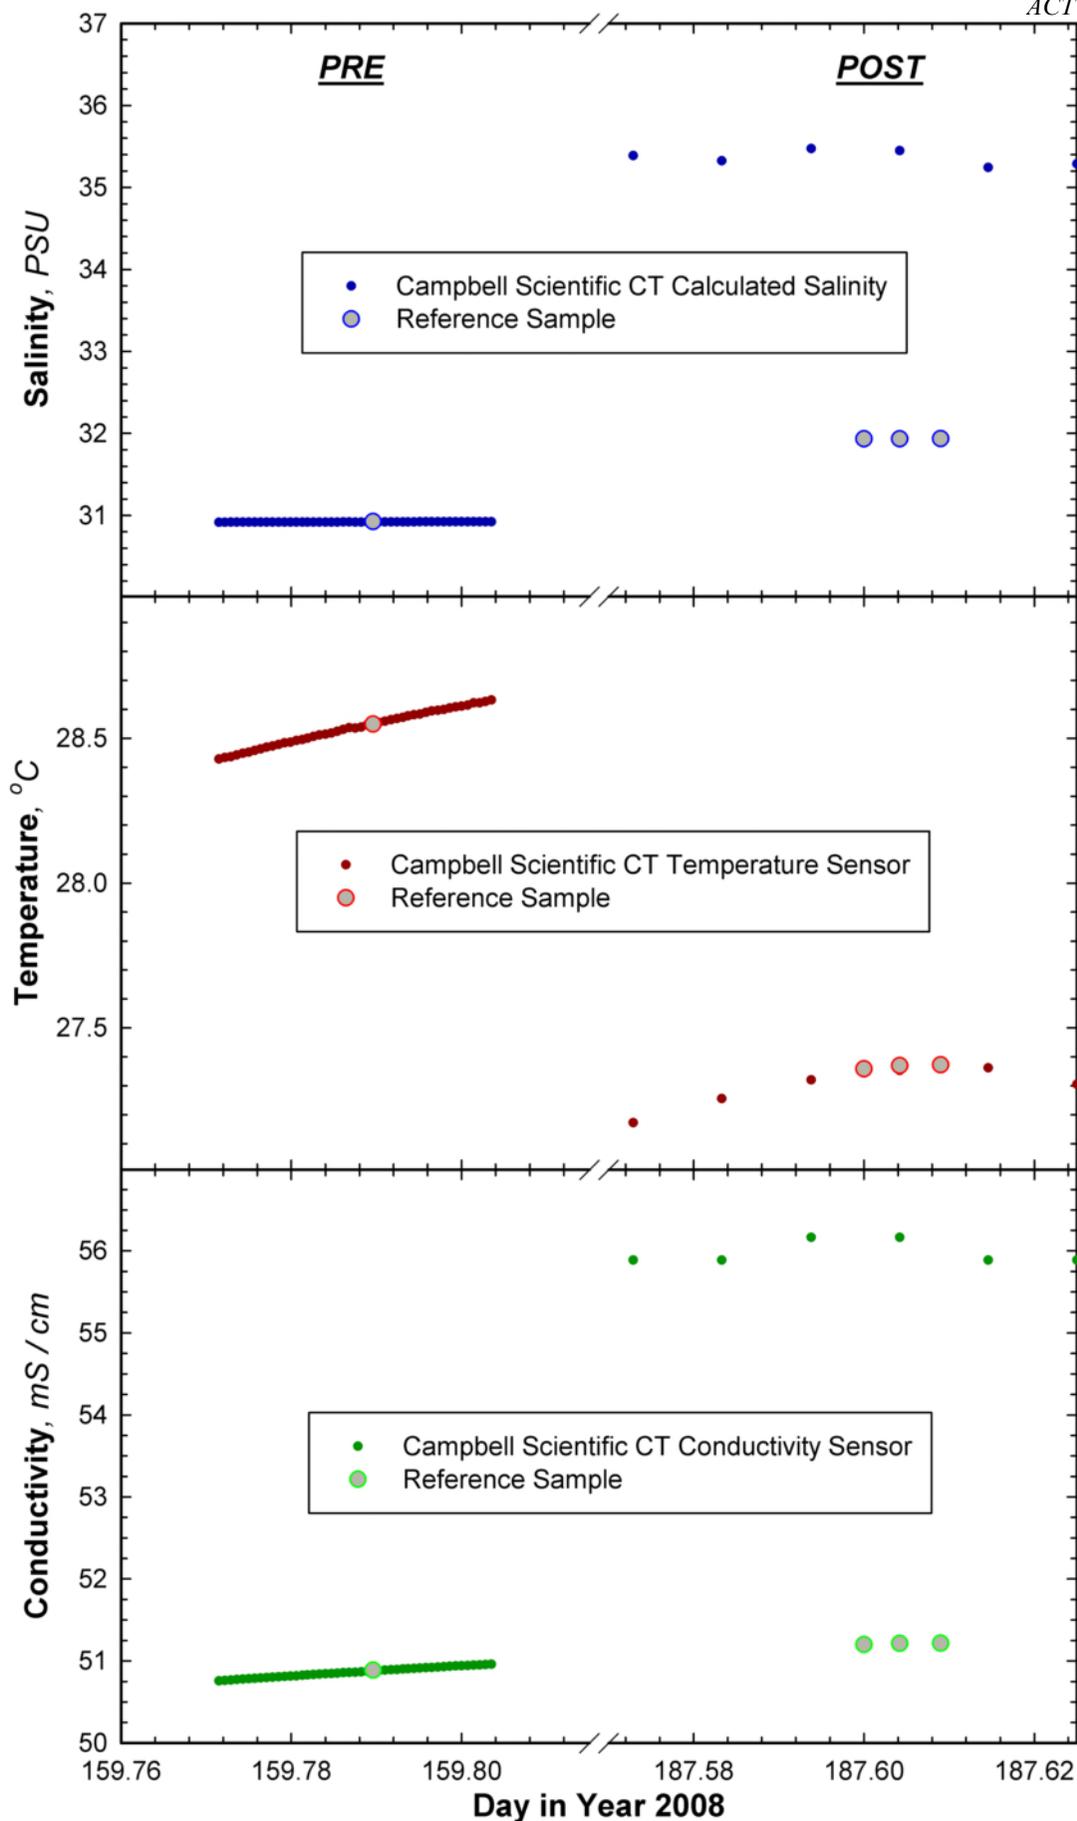
**Figure 15.** Pre- and Post-deployment reference checks in tanks of natural seawater at SkIO. Post-deployment tests conducted after cleaning instrument of all fouling material according to manufacturer's recommendations.

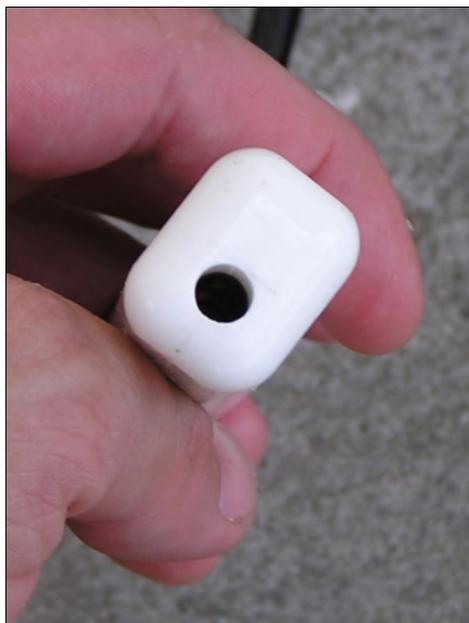
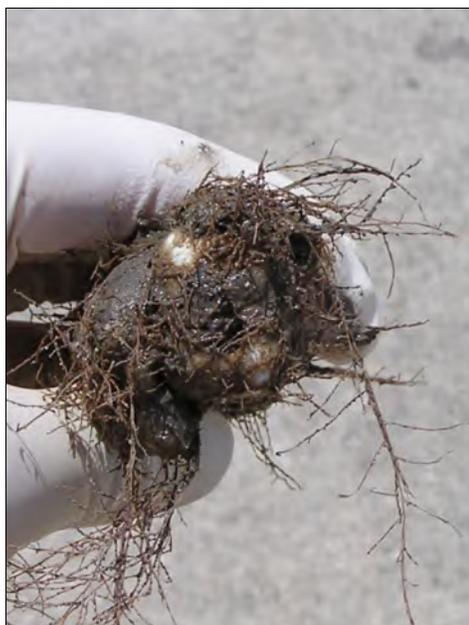
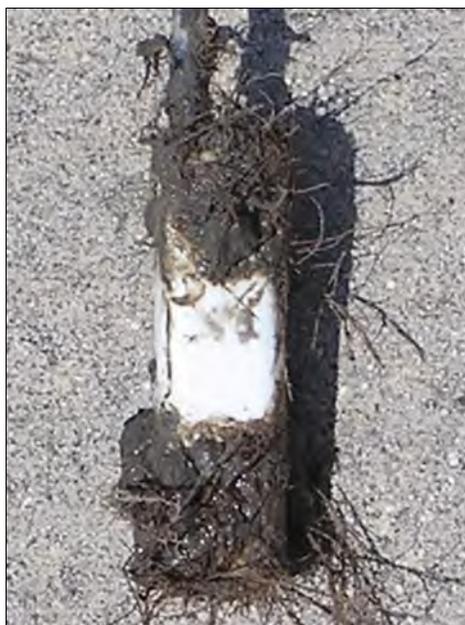
Before and after photos were taken of the instrument to examine the extent and possible impacts of bio-fouling (Fig. 16). A significant amount of soft (plant material) and hard (calcified) bio-fouling was evident across most of the instrument body by the end of the deployment including directly within the conductivity cell.

Prior to Deployment (Close-up)

After Deployment (Close-up)

After Deployment (Full View)
