## PERFORMANCE VERIFICATION STATEMENT for Campbell Scientific CS547A and OBS-3A Salinity Probes

<b>TECHNOLOGY TYPE:</b>	Coupled conductivity and temperature sensors with instrument based algorithms for estimation of salinity
<b>APPLICATION:</b>	In situ estimates of salinity for coastal moored and profiled deployments
<b>PARAMETERS EVALUATED:</b>	Response linearity, accuracy, precision and reliability
<b>TYPE OF EVALUATION:</b>	Laboratory and Field Performance Verification
<b>DATE OF EVALUATION:</b>	Testing conducted from May through October 2008
<b>EVALUATION PERSONNEL:</b>	S. Gilbert, K. Gundersen, T. Johengen, T. McKissack, M. McIntyre, A. Pinchuk, H. Purcell, C. Robertson, D. Schar, G.J. Smith, M. Tamburri and D. Wells.

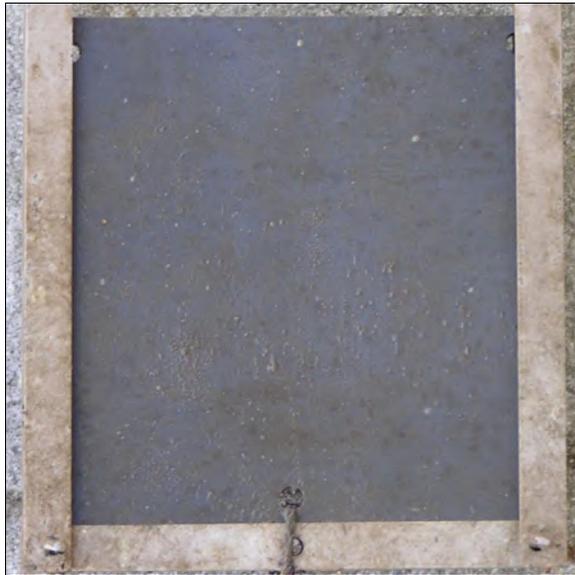
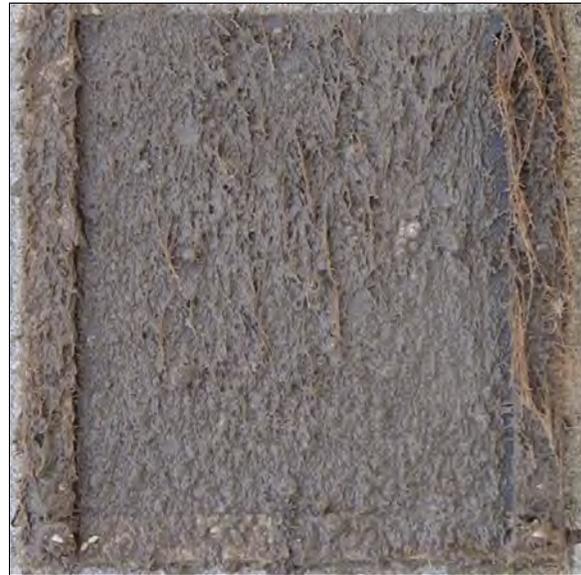
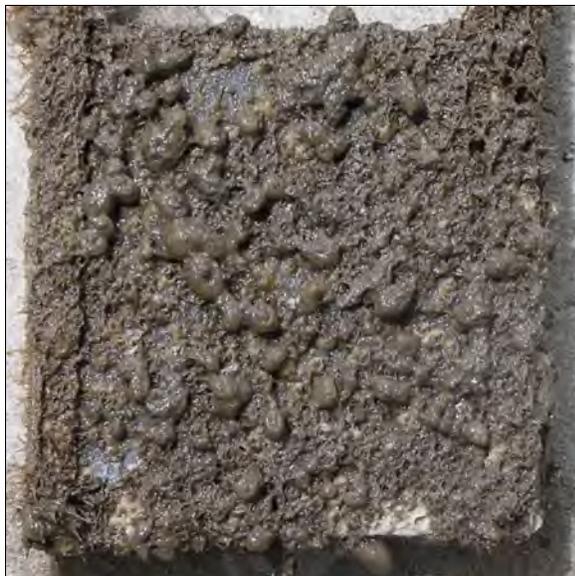
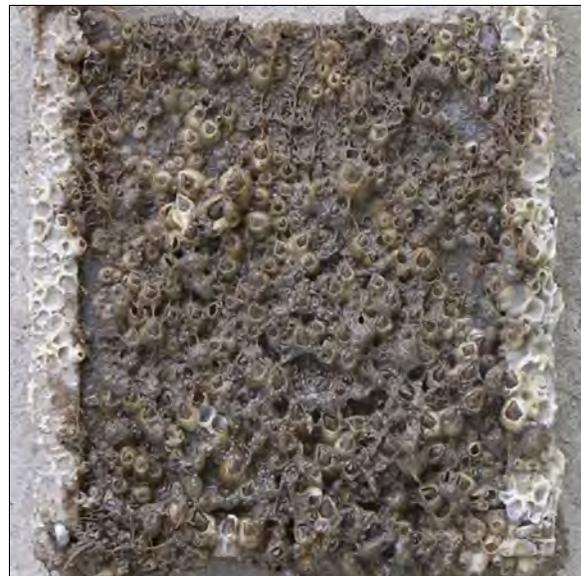
Bio-fouling plates were retrieved and photographed once each week throughout the deployment to help define the rate and extent of biofouling within the test environment (Fig. 17). Significant amounts of soft biofouling were evident by week 2 and progressed into heavy amounts of hard, encrusting biofouling at the Georgia test site.

SkIO Site Week 1

SkIO Site Week 2

SkIO Site Week 3

SkIO Site Week 4

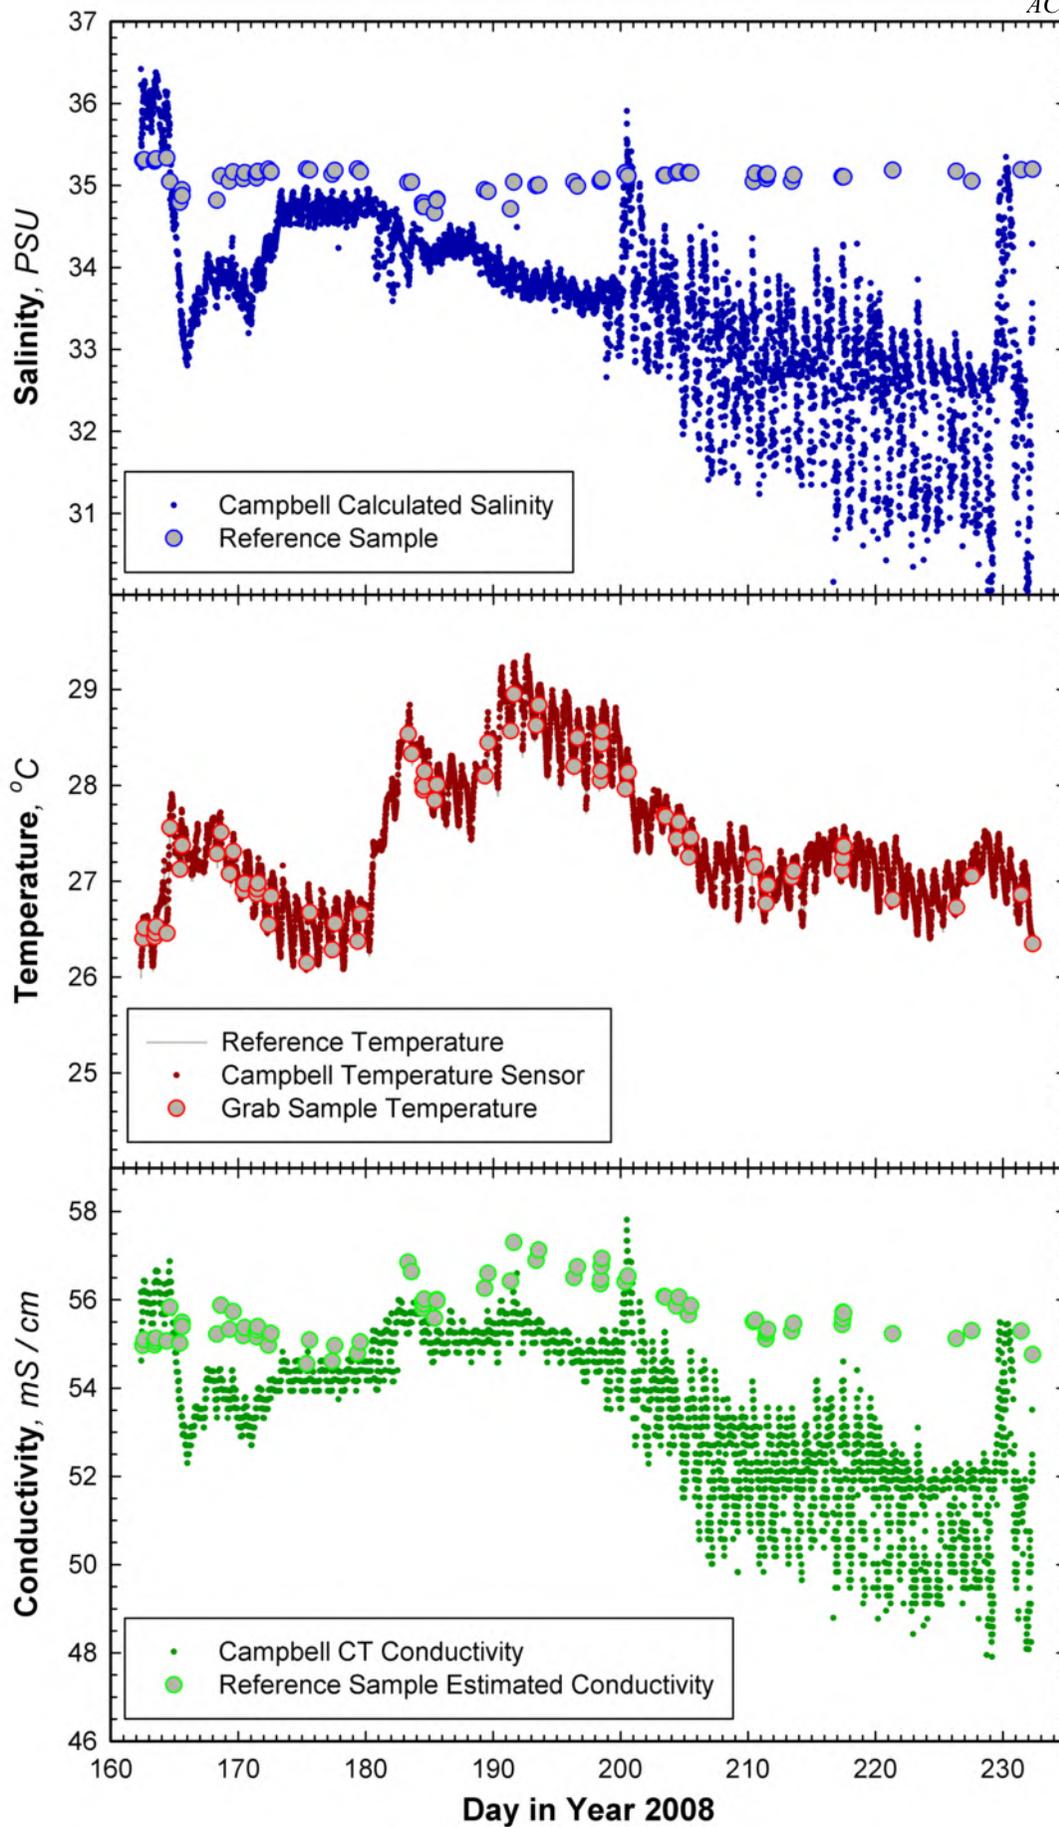
**Figure 19.** Time series of instrument measurements and corresponding reference samples acquired during the HI field deployment.

Time series data of in situ measured conductivity and temperature, and derived salinity, for the HI field test were plotted against corresponding results from the laboratory analyzed reference samples and reference temperature logger (Fig. 19). The measurement error in salinity ranged from 0.974 to -2.736 psu, with an overall mean of -1.006 psu (Fig. 20). As seen at other test sites the probe tended to produce underestimates after an initial few days of deployment. The error in instrument derived salinity was again due to the performance or calibration of the conductivity sensor which had an average offset of  $-1.341 \pm 1.115$  mS/cm. The temperature sensor was stable throughout the deployment with an average offset of  $0.0921 \pm 0.0575$  °C relative to the reference temperature logger. Results of the pre- and post-deployment exposure tests, after the instrument was cleaned to remove all biofouling, are shown in figure 21. The probe did not stabilize fast enough to get an accurate assessment of any change in calibration factors between the pre- and post-deployment periods. The amount of biofouling that developed on the instrument during the deployment is shown in figure 22, and a time-series of biofouling rates on PVC tiles is shown in figure 23.

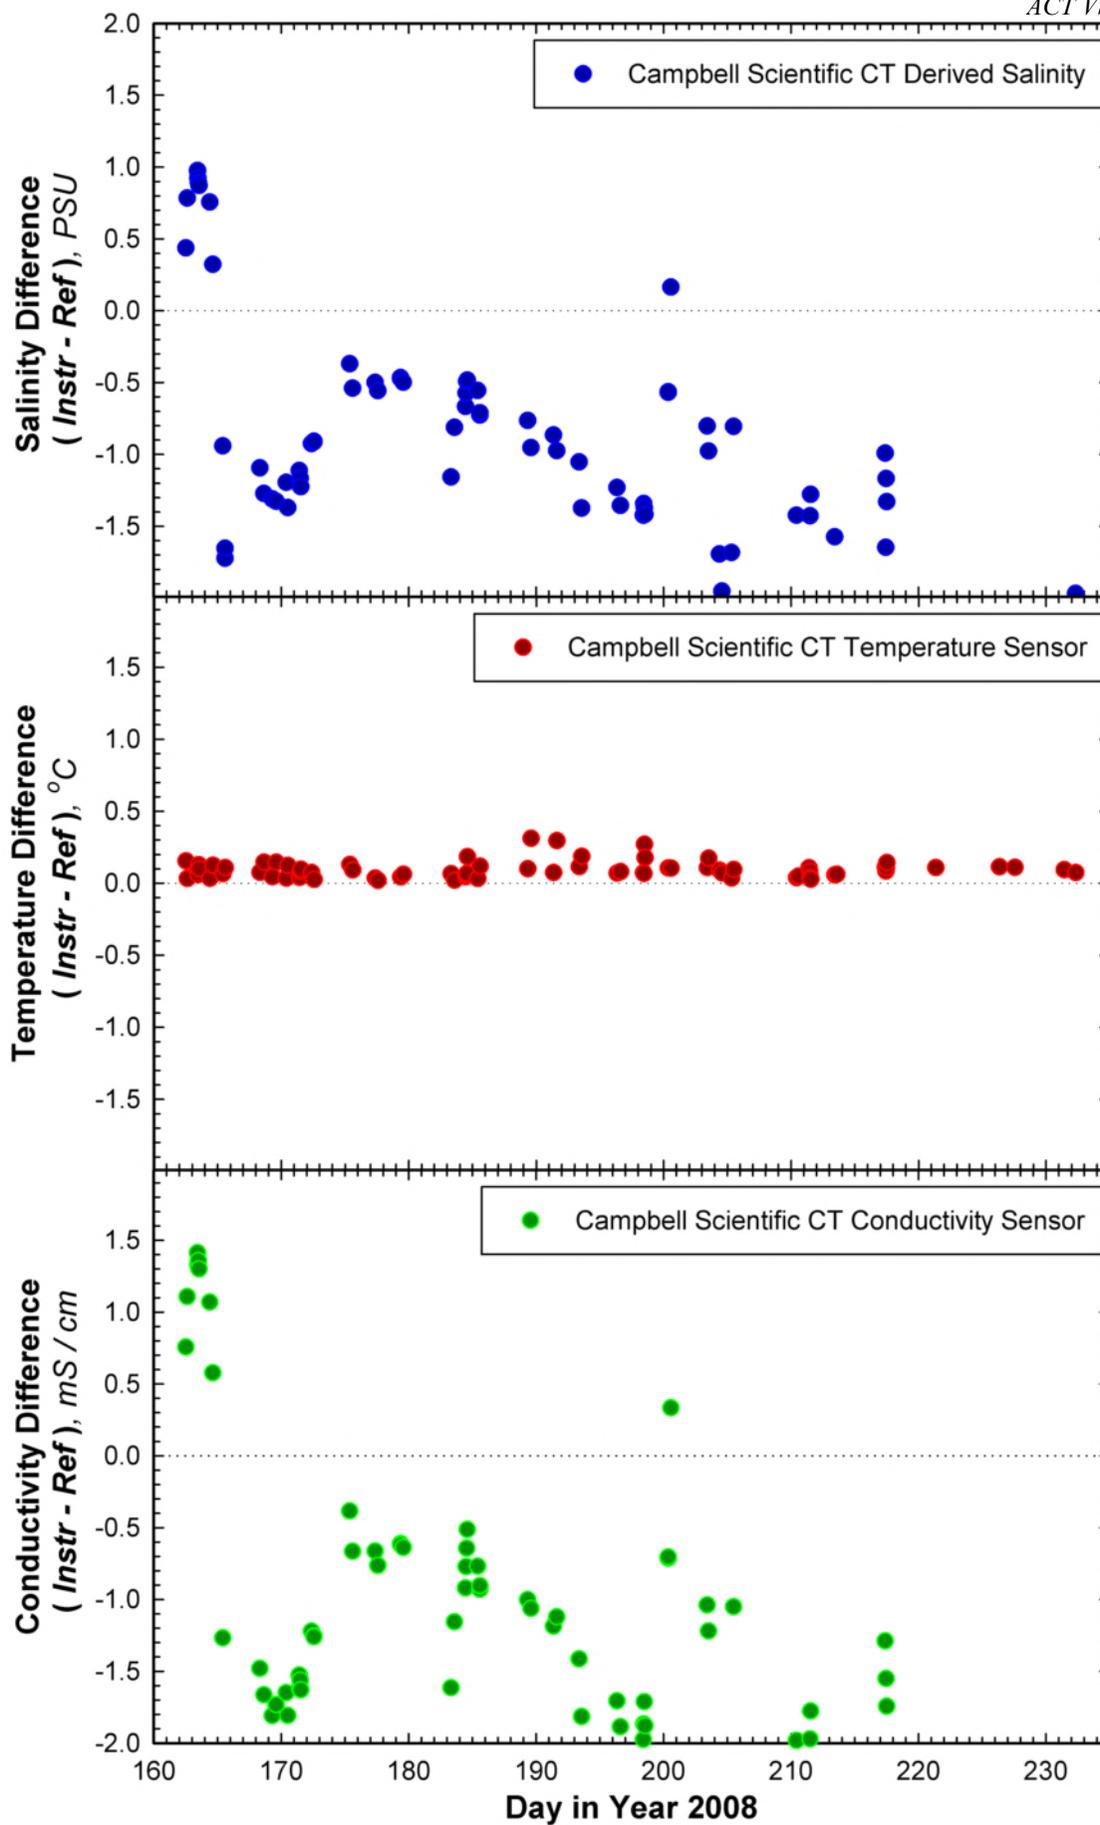
**Figure 20.** Assessment of relative accuracy of instrument time series measurements during the HI field deployment.

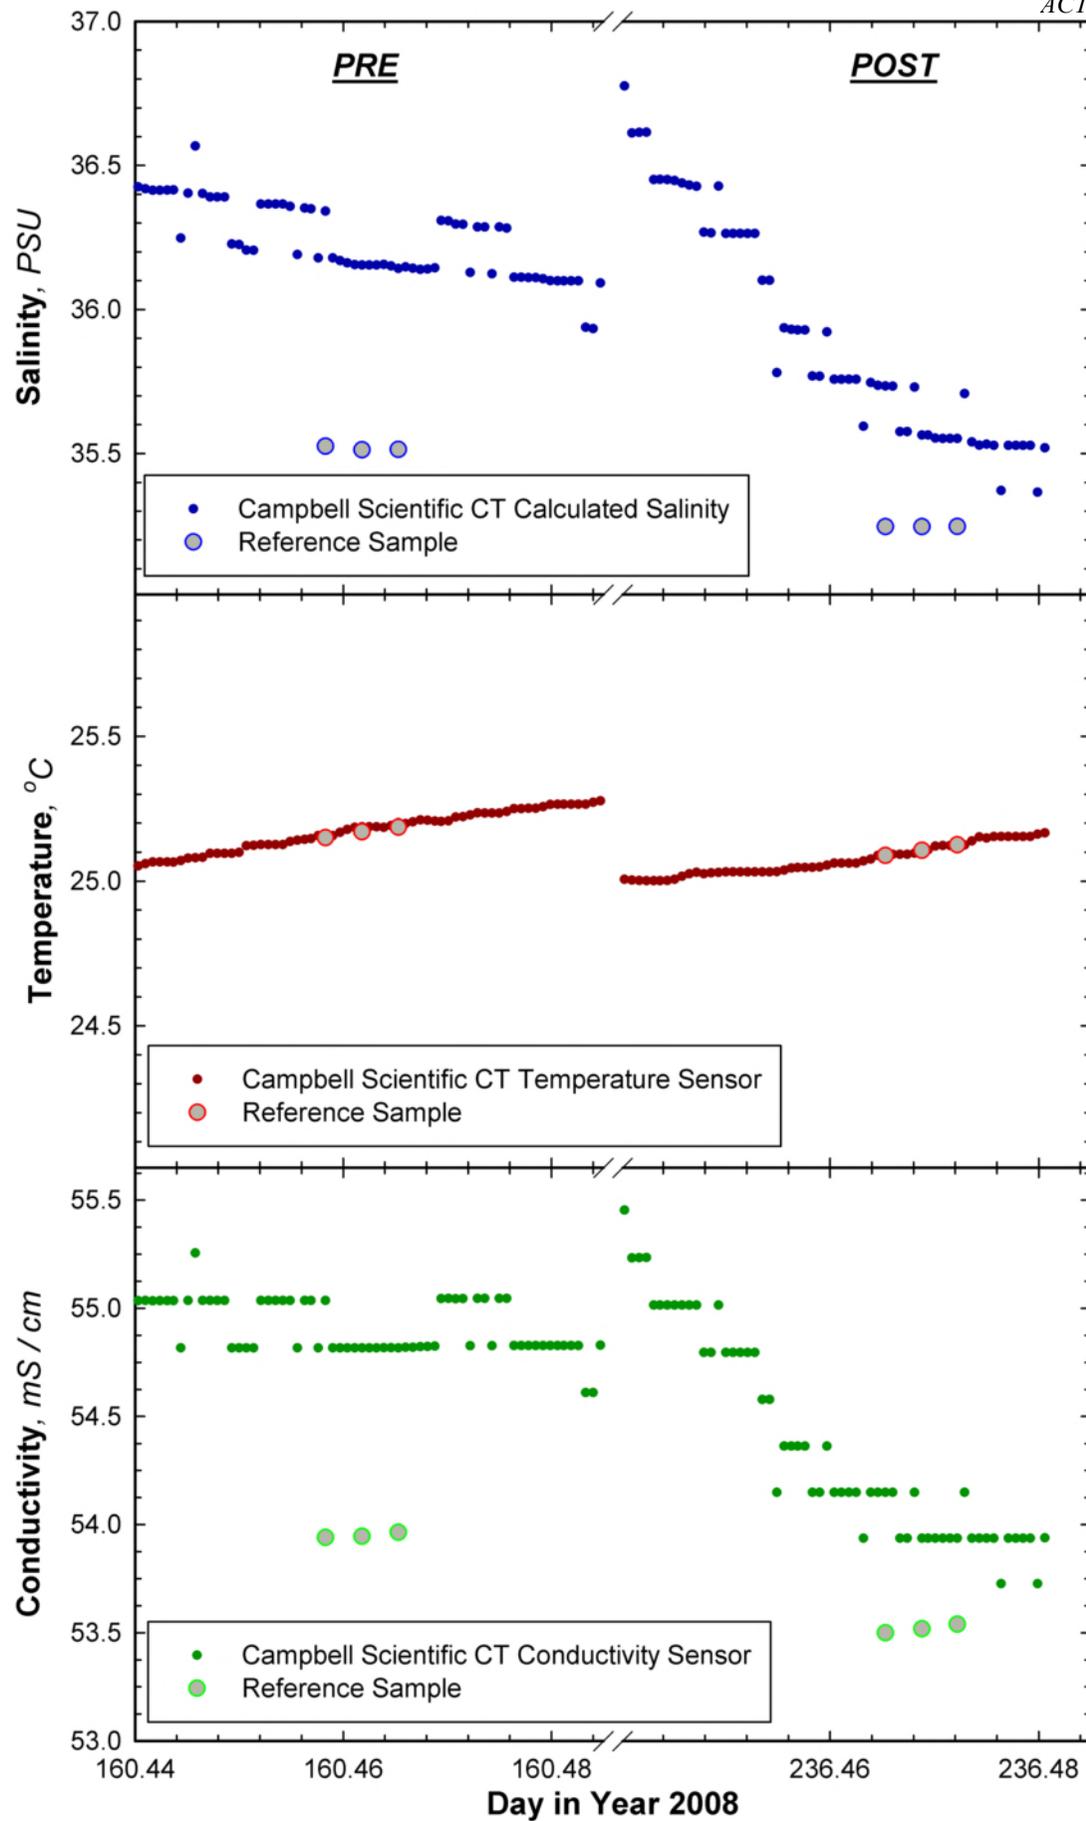
**Figure 21.** Pre- and Post-deployment reference checks in tanks of natural seawater at HI. Post-deployment tests conducted after cleaning instrument of all fouling material according to manufacturer's recommendations.

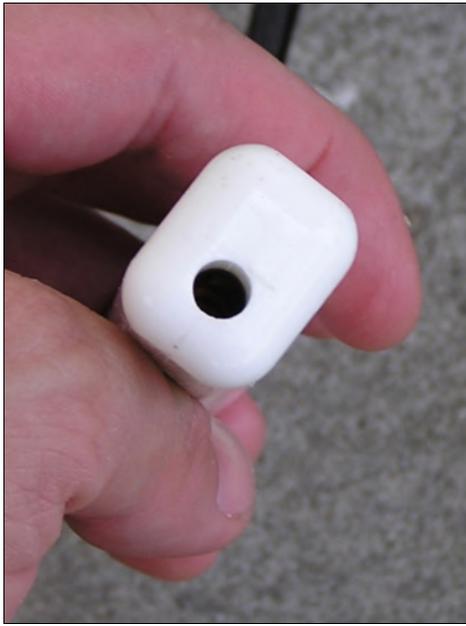
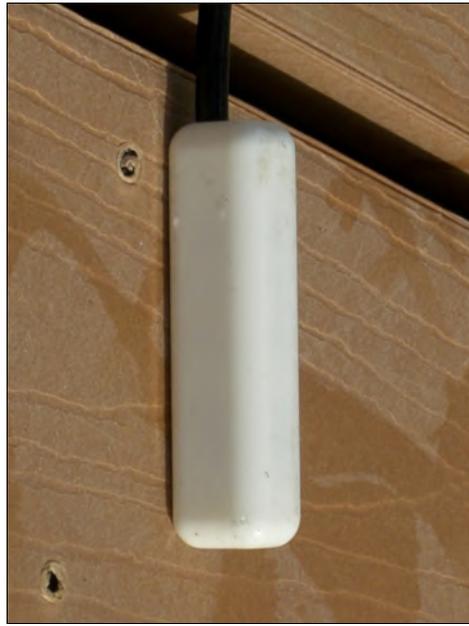
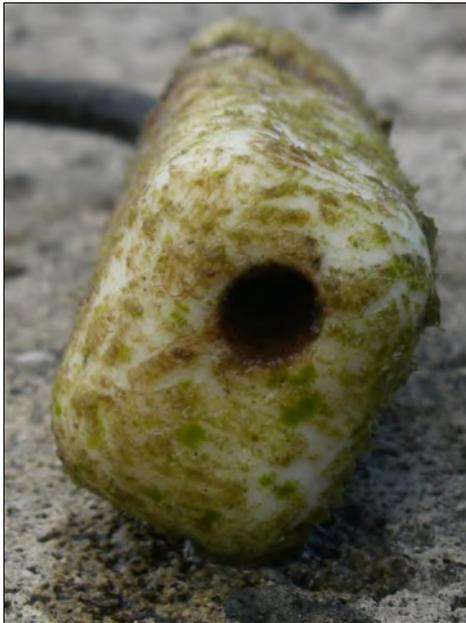
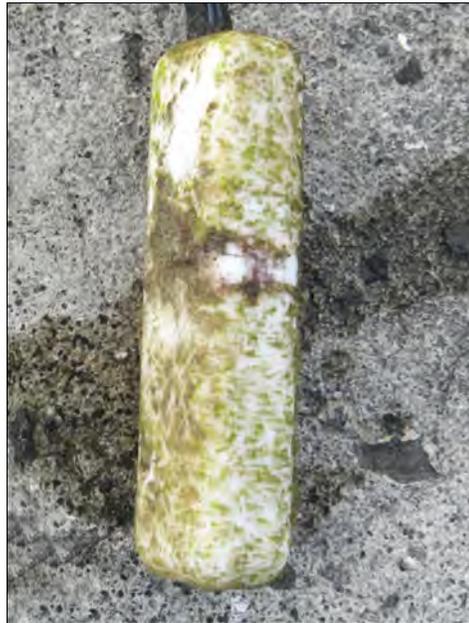
Before and after photos were taken of the instrument to examine the extent and possible impacts of bio-fouling (Fig. 22). The extent of bio-fouling was significantly less at this test site relative to FL or GA despite the longer deployment period and was mostly comprised of plant material and worm cases.

Prior to Deployment (Close-up)

Prior to Deployment (Full View)

After Deployment (Close-up)

After Deployment (Full View)

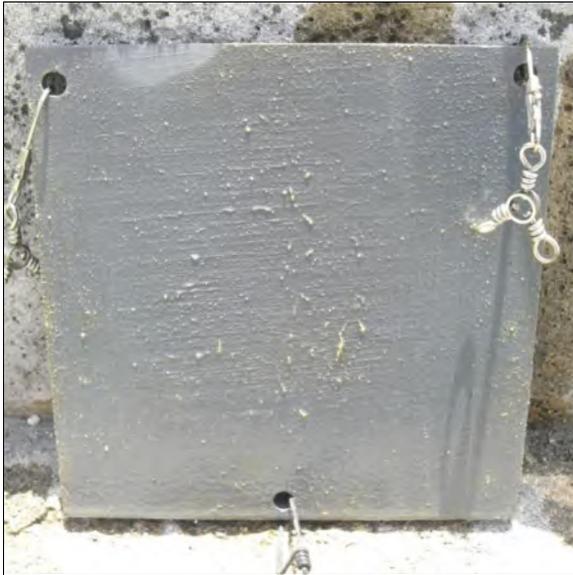
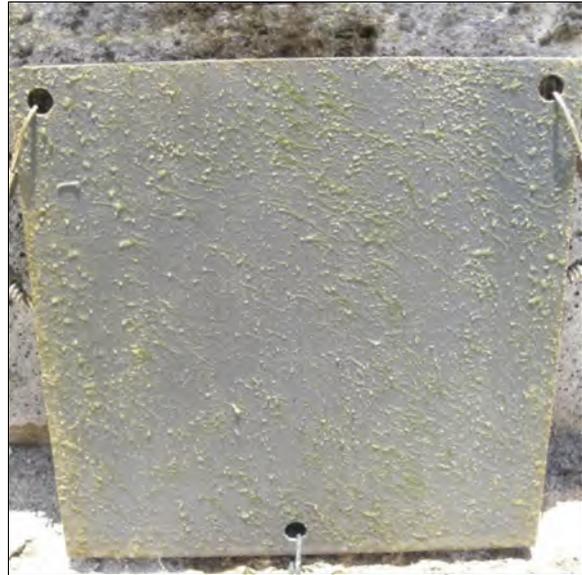
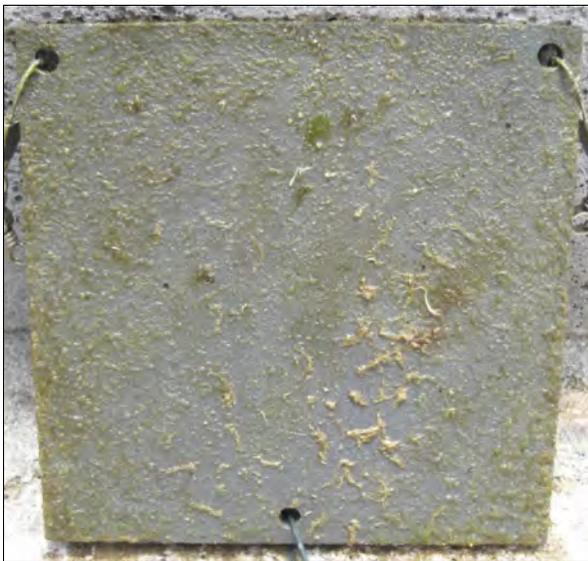
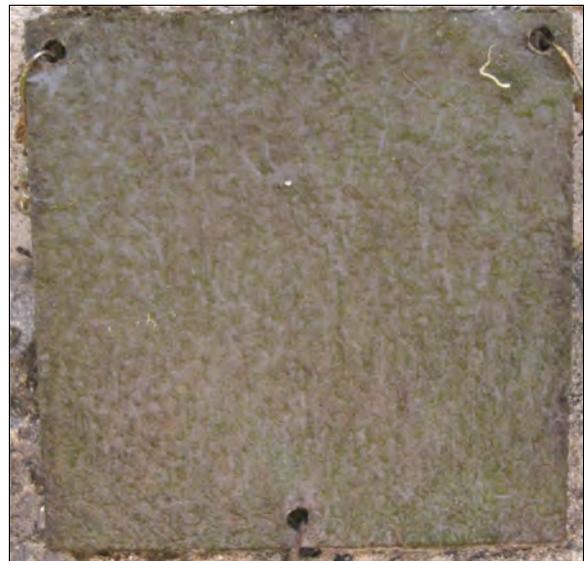
Bio-fouling plates were retrieved and photographed once each week throughout the deployment to help define the rate and extent of biofouling within the test environment. A subset of the plate photographs covering weeks 1, 2, 4, and 8 are shown in Figure 23. The extent of bio-fouling was significantly less at this test site relative to FL or GA despite the longer deployment period and was mostly comprised of plant material and worm cases.

HI Site Week 1

HI Site Week 2

HI Site Week 4

HI Site Week 8

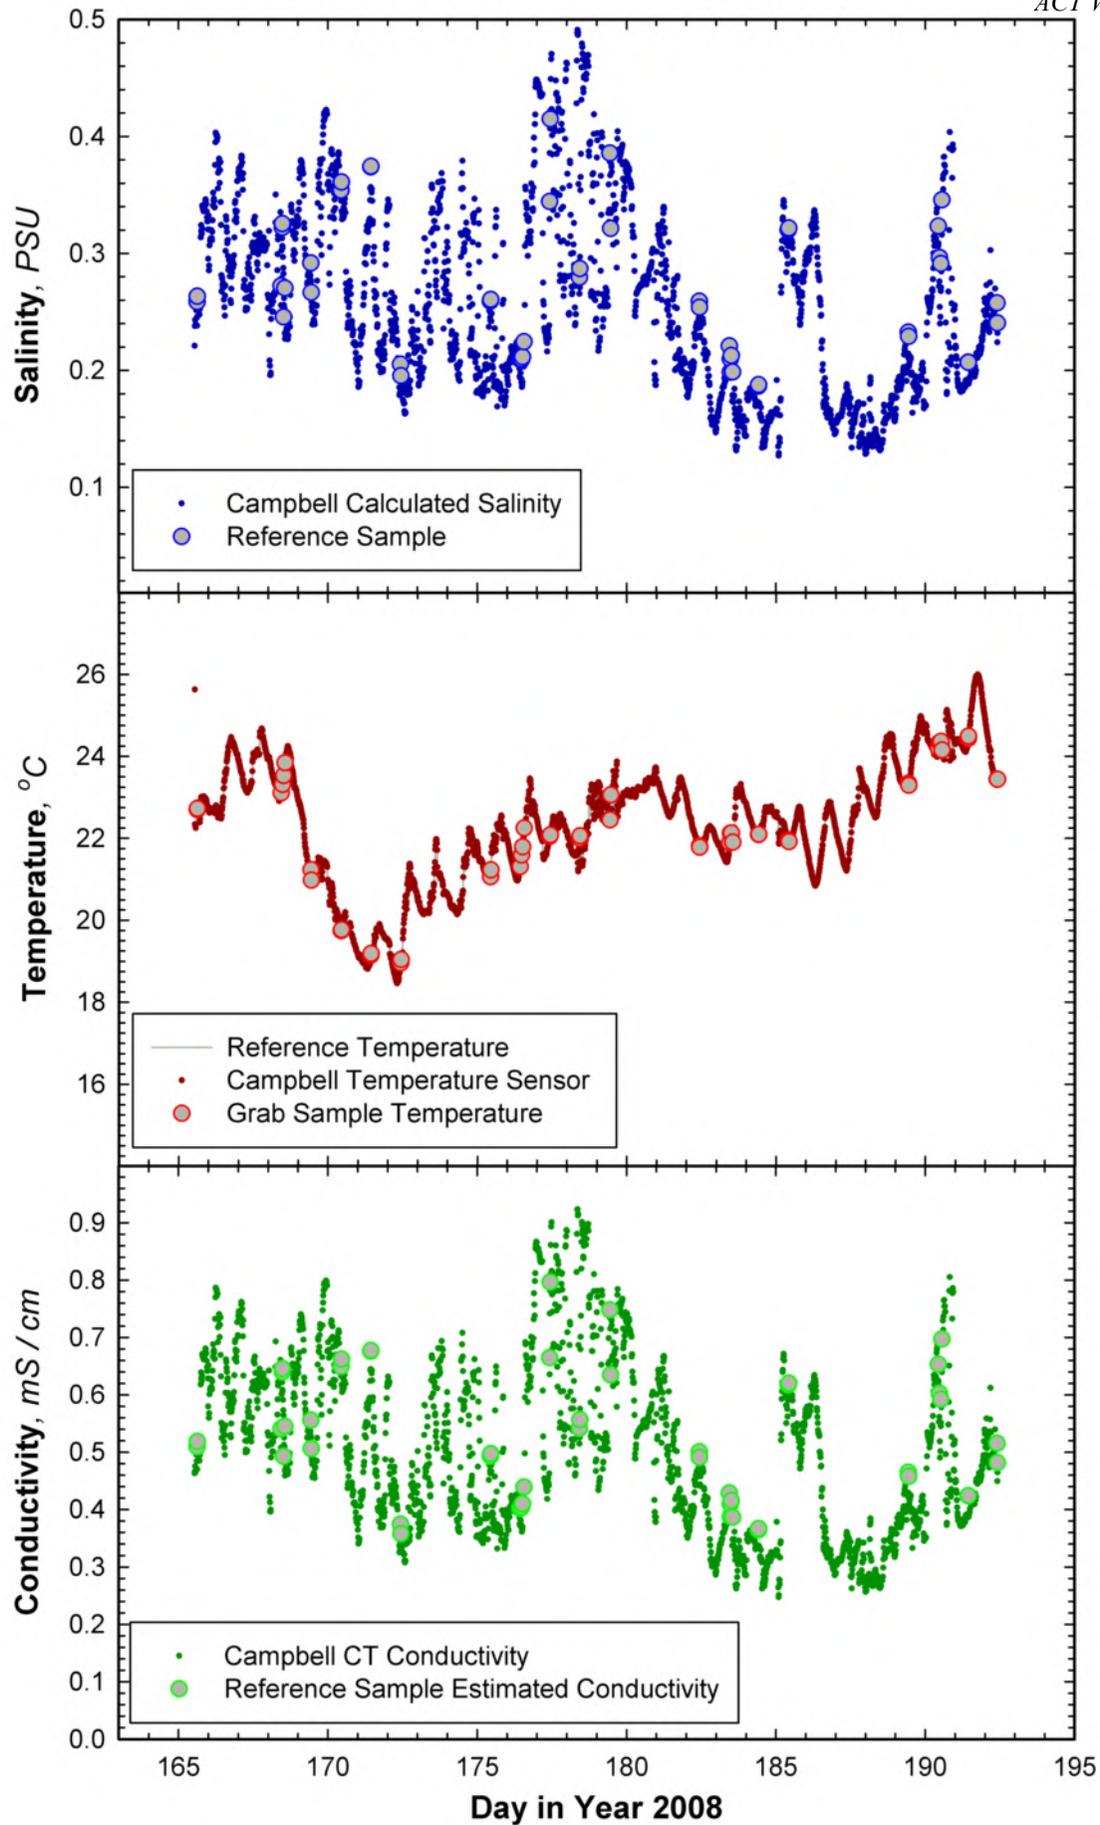
**Figure 25.** Time series of instrument measurements and corresponding reference samples acquired during the GL field deployment.

Time series data of in situ measured conductivity and temperature, and derived salinity, for the MI field test were plotted against corresponding results from the laboratory analyzed reference samples and reference temperature logger (Fig. 25). The CS547A measurements closely matched reference sample measurements throughout the entire 29 day deployment and captured several sharp rises and falls in both conductivity and temperature at this site. The average measurement error in salinity, conductivity and temperature was -0.0148, -0.0285, and 0.0082, respectively over the deployment (Fig. 26). The offset in the instrument salinity, conductivity, and temperature measurements was nearly identical between the pre- and post-deployment exposure test (Fig. 27). In general there was very little fouling impact at this site. The amount of fouling that developed on the instrument during the deployment is shown in figure 28 and a time-series of biofouling rates on PVC tiles is shown in figure 29.

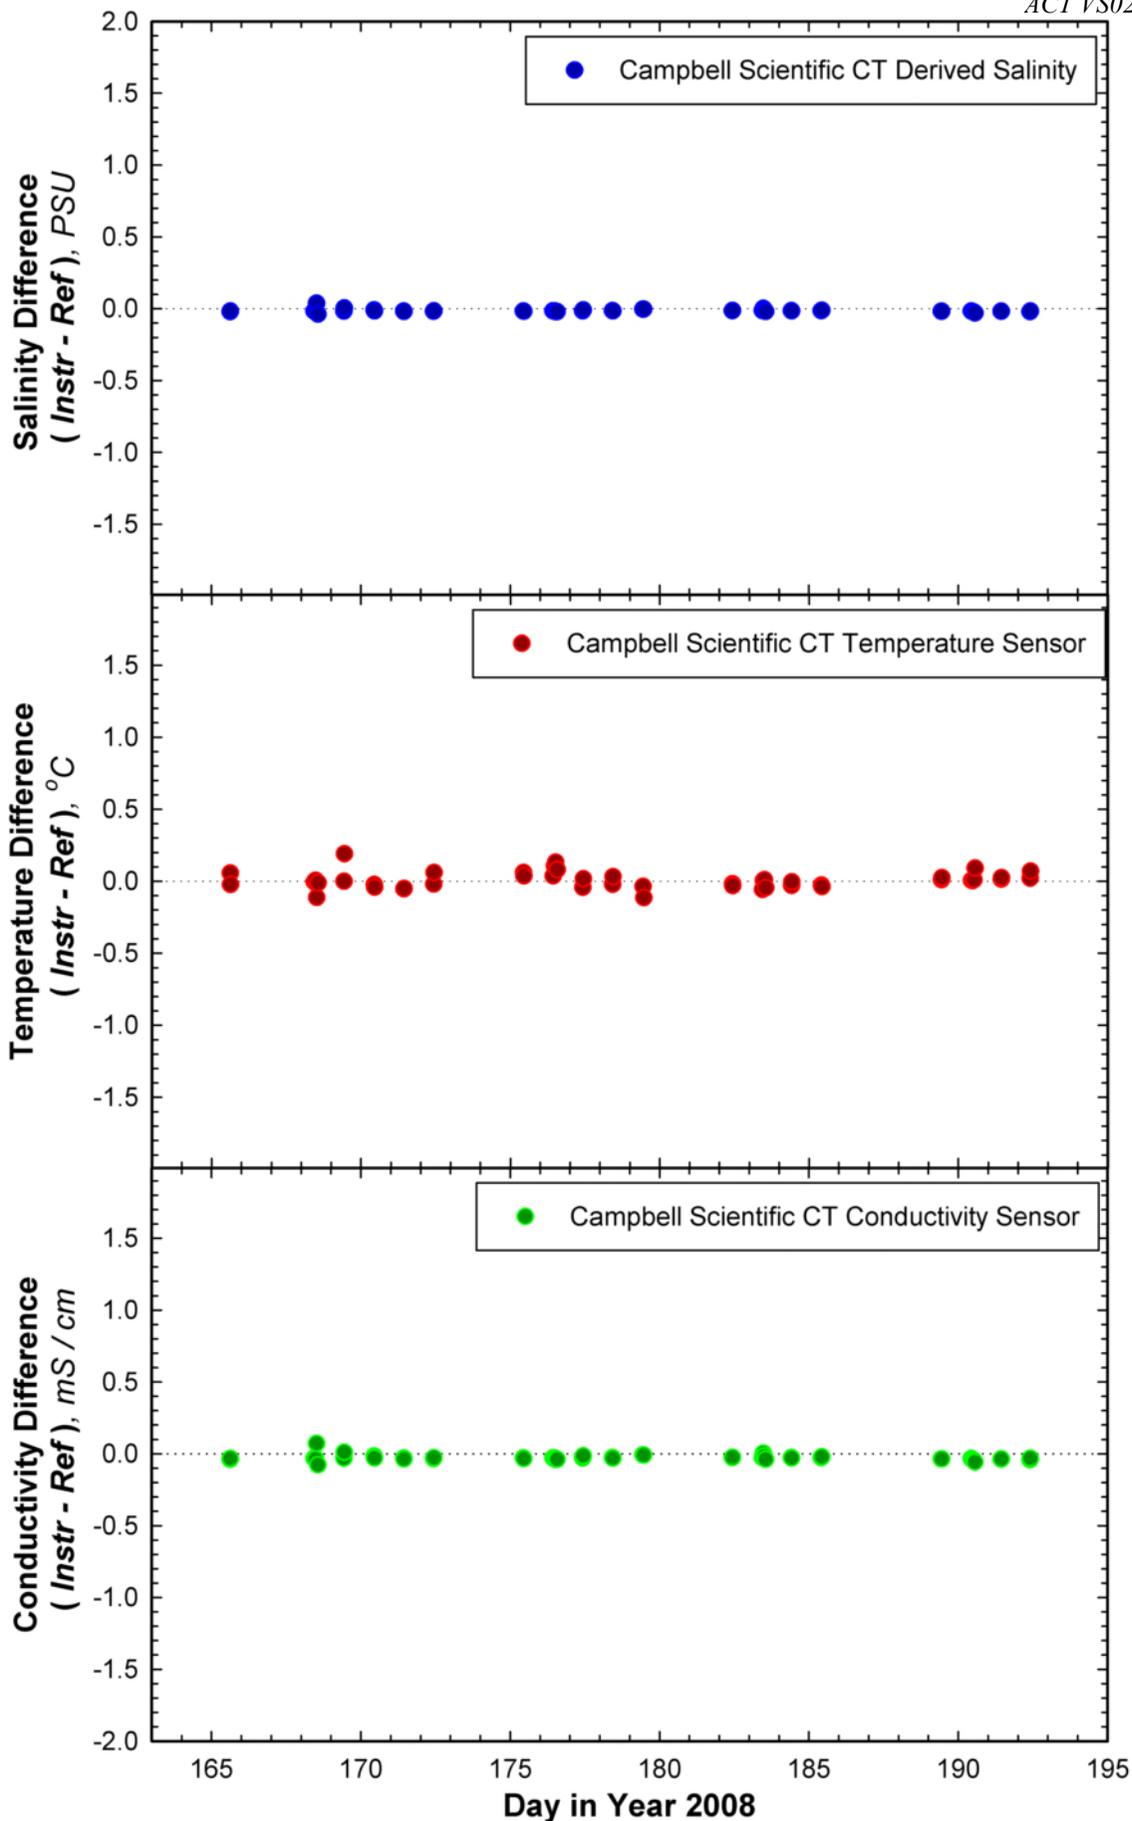
**Figure 26.** Assessment of relative accuracy of instrument time series measurements during the GL field deployment.

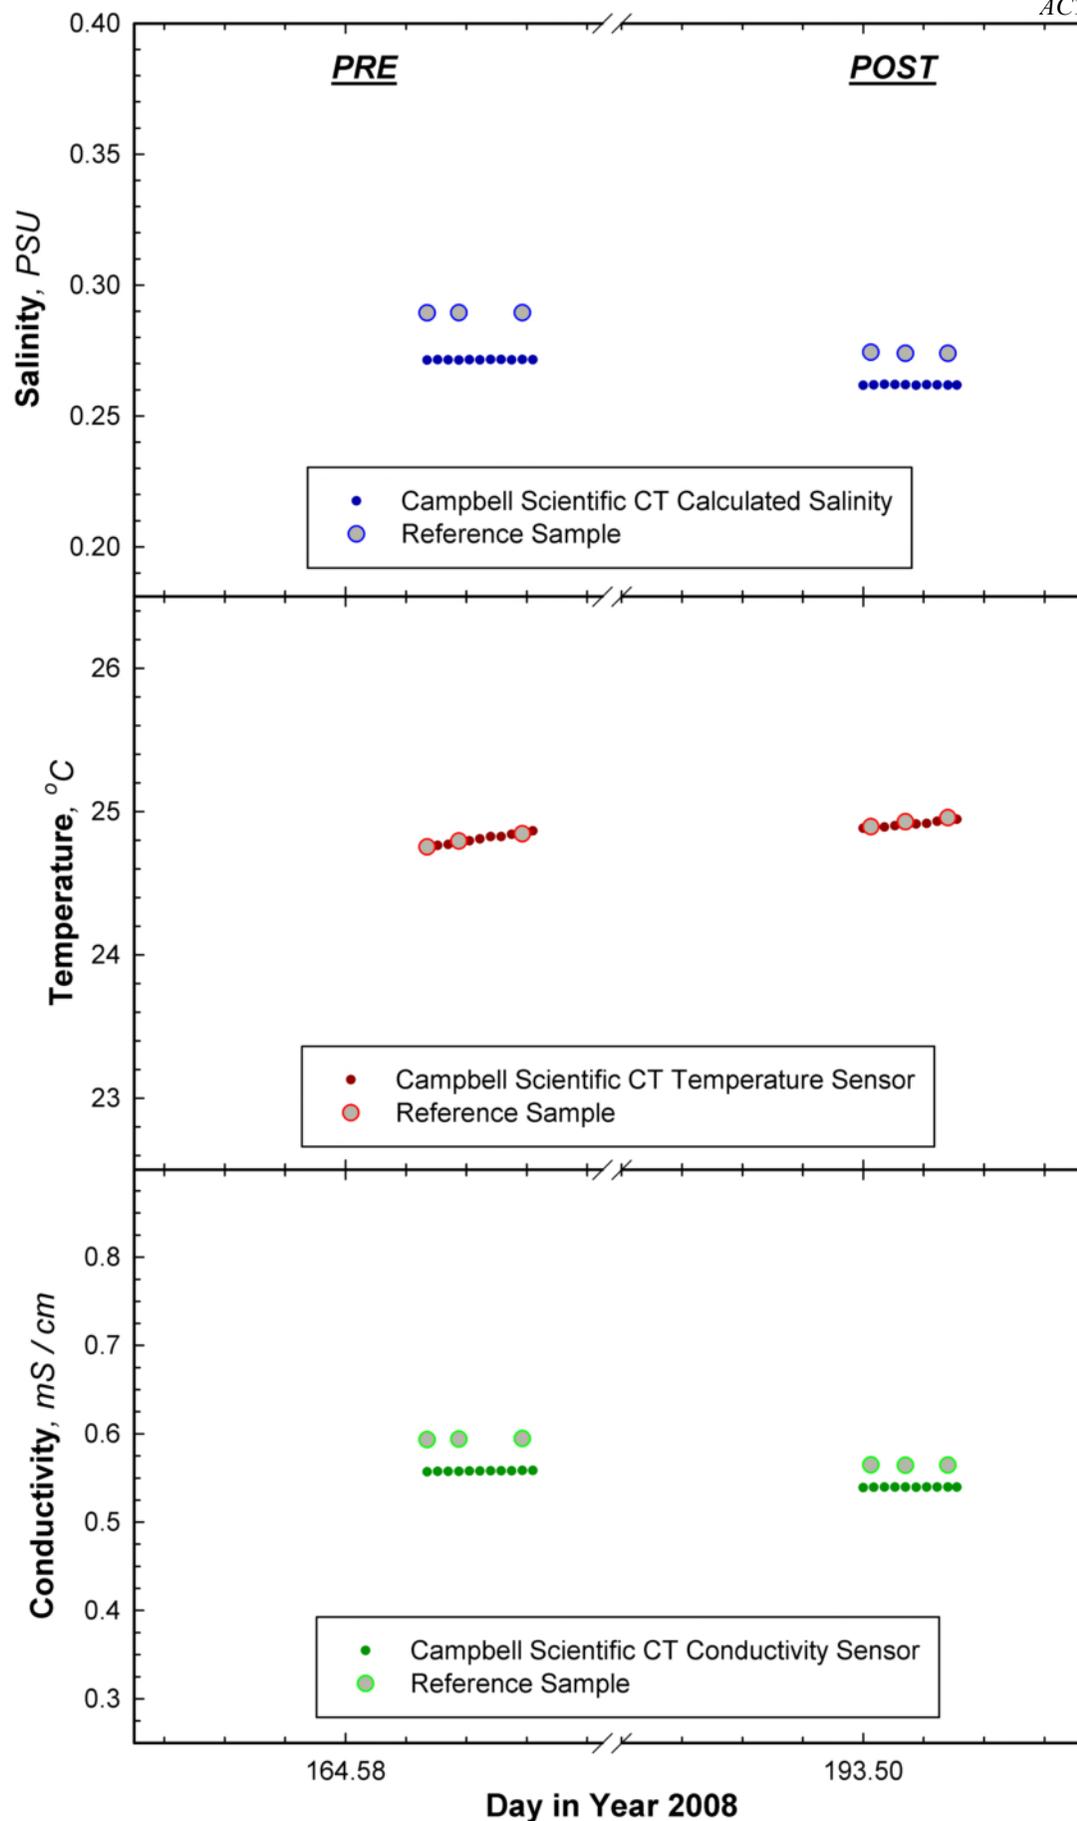
**Figure 27.** Pre- and Post-deployment reference checks in tanks of river water at GL. Post-deployment tests conducted after cleaning instrument of all fouling material according to manufacturer's recommendations.

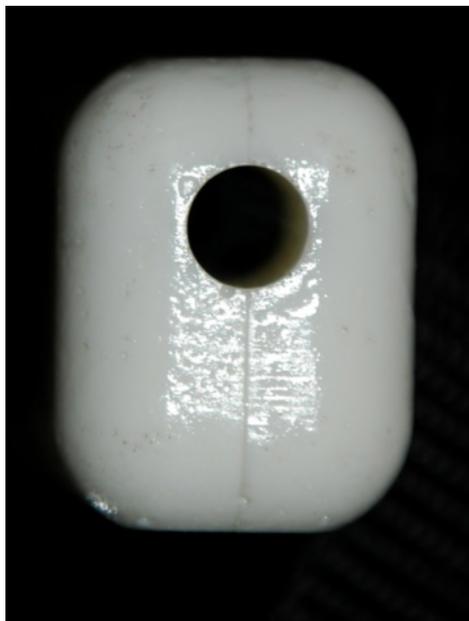
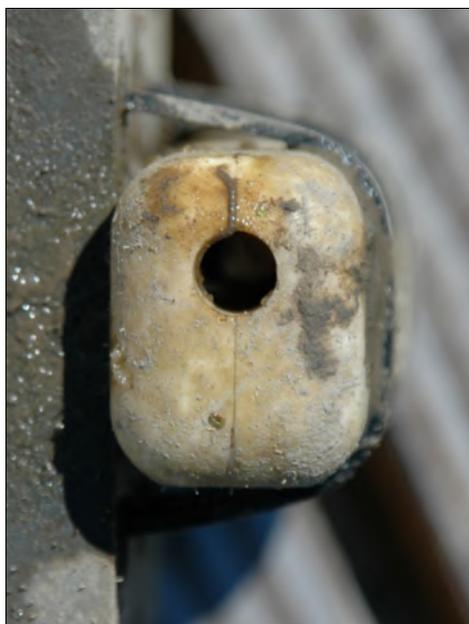
Before and after photos were taken of the instrument to examine the extent and possible impacts of bio-fouling (Fig. 28). The extent of bio-fouling was quite low at the MI test site and consisted of only soft plant material.

Prior to Deployment (Close-up)

After Deployment (Close-up)

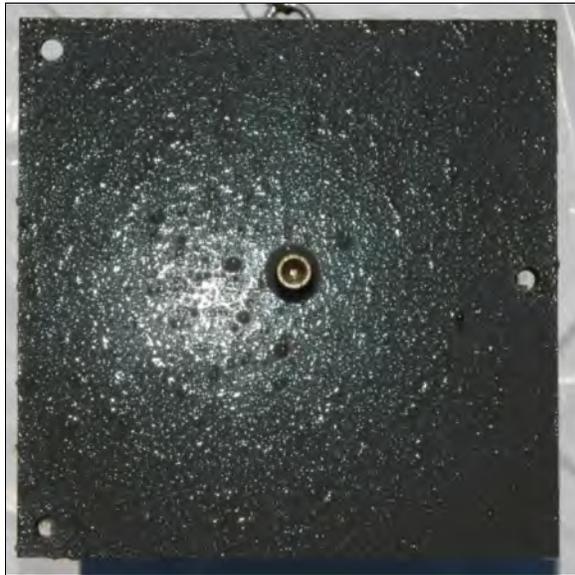
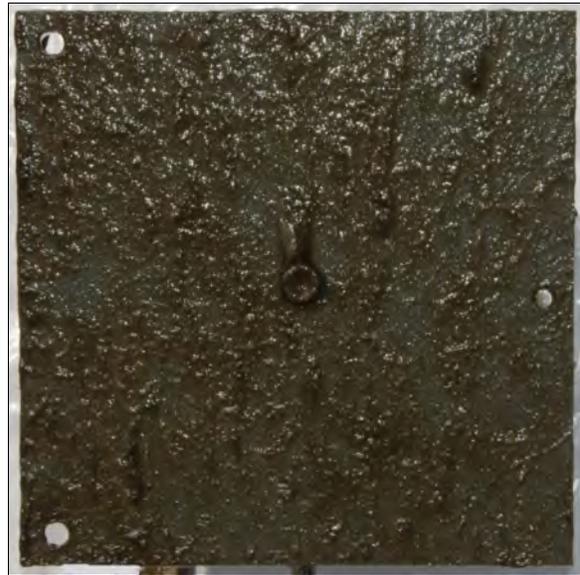
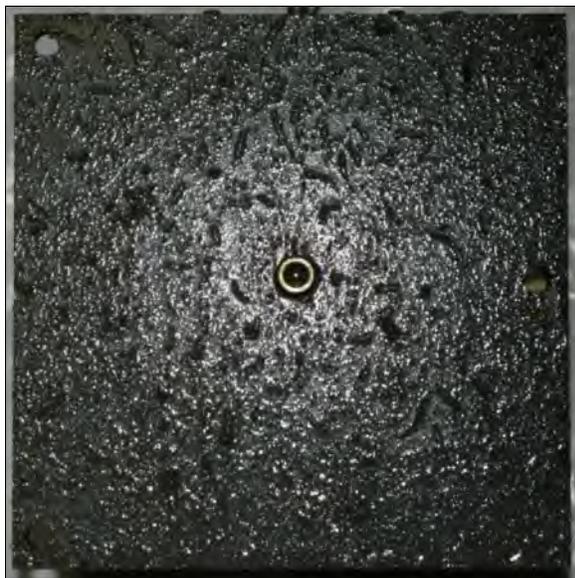
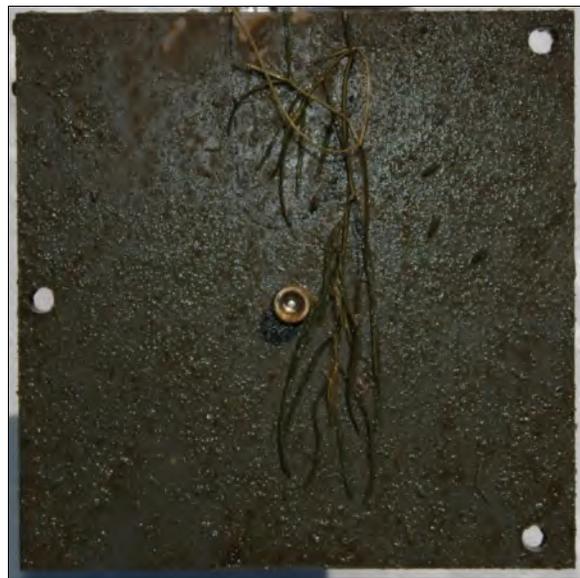
Bio-fouling plates were retrieved and photographed once each week throughout the deployment to help define the rate and extent of biofouling within the test environment (Fig. 29). Biofouling material was mostly comprised of plant material and developed rather quickly but did not appear to accumulate significantly once the original surface was covered.

Great Lakes Site Week 1

Great Lakes Site Week 2

Great Lakes Site Week 3

Great Lakes site Week 4

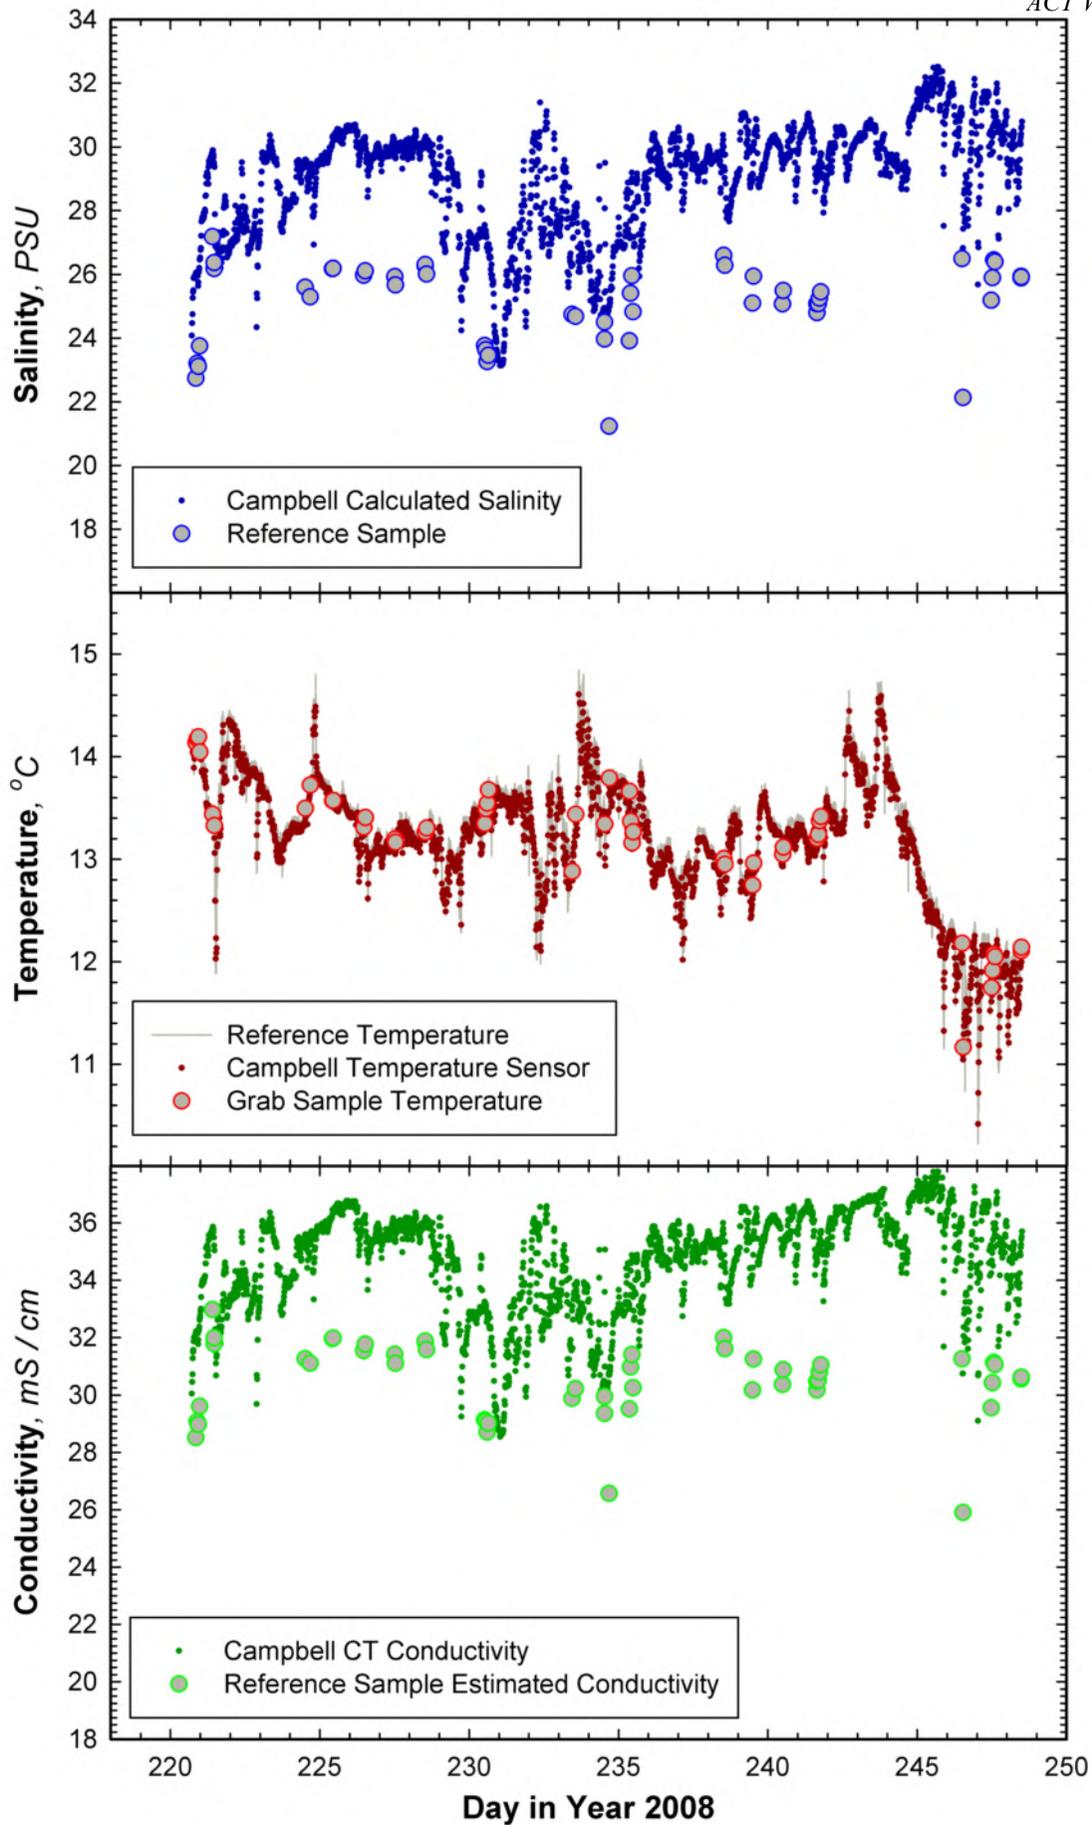
**Figure 31.** Time series of instrument measurements and corresponding reference samples acquired during the AK field deployment.

Time series data of in situ measured conductivity and temperature, and derived salinity, for the AK field test were plotted against corresponding results from the laboratory analyzed reference samples and reference temperature logger (Fig. 31). The relative accuracy of the instrument measured salinity, conductivity, and temperature were depicted as numerical differences from the reference values and plotted over time (Fig. 32). The measurement error in salinity ranged from 0.924 to 4.69 with a mean of 3.69 psu. For this deployment the response was more consistent throughout the deployment but ended higher over the last 10 days. The mean measurement error of the temperature sensor over the deployment period was  $-0.0792$  °C. Results of the pre- and post-deployment exposure tests, after the instrument was cleaned to remove all biofouling, are shown in figure 33. Temperature response was nearly identical between pre- and post-exposure tests, however, offsets in conductivity and derived salinity measure increased significantly for the post-test. The amount of fouling that developed on the instrument during the deployment is shown in figure 34 and a time-series of biofouling rates on PVC tiles is shown in figure 35.
