## PERFORMANCE VERIFICATION STATEMENT for Campbell Scientific CS547A and OBS-3A Salinity Probes

<b>TECHNOLOGY TYPE:</b>	Coupled conductivity and temperature sensors with instrument based algorithms for estimation of salinity
<b>APPLICATION:</b>	In situ estimates of salinity for coastal moored and profiled deployments
<b>PARAMETERS EVALUATED:</b>	Response linearity, accuracy, precision and reliability
<b>TYPE OF EVALUATION:</b>	Laboratory and Field Performance Verification
<b>DATE OF EVALUATION:</b>	Testing conducted from May through October 2008
<b>EVALUATION PERSONNEL:</b>	S. Gilbert, K. Gundersen, T. Johengen, T. McKissack, M. McIntyre, A. Pinchuk, H. Purcell, C. Robertson, D. Schar, G.J. Smith, M. Tamburri and D. Wells.

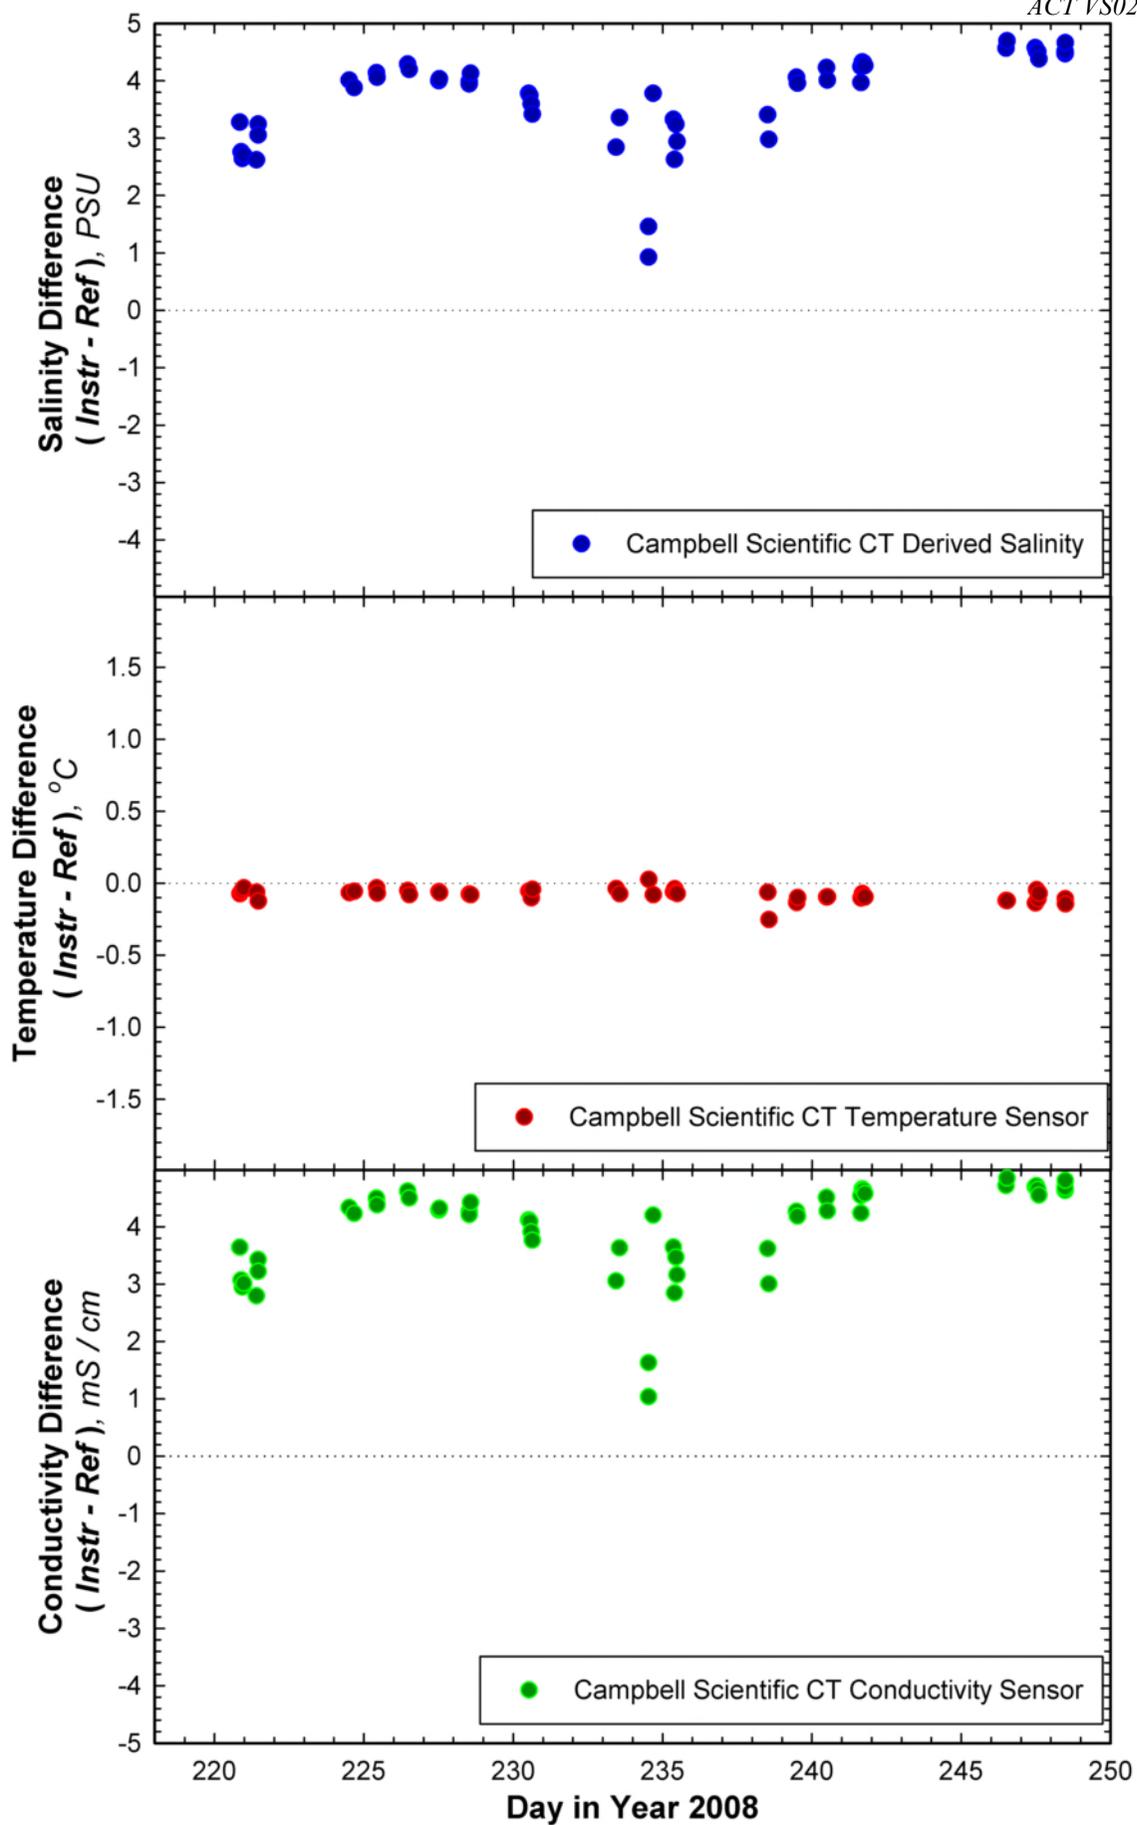
**Figure 32.** Assessment of relative accuracy of instrument time series measurements during the AK field deployment.

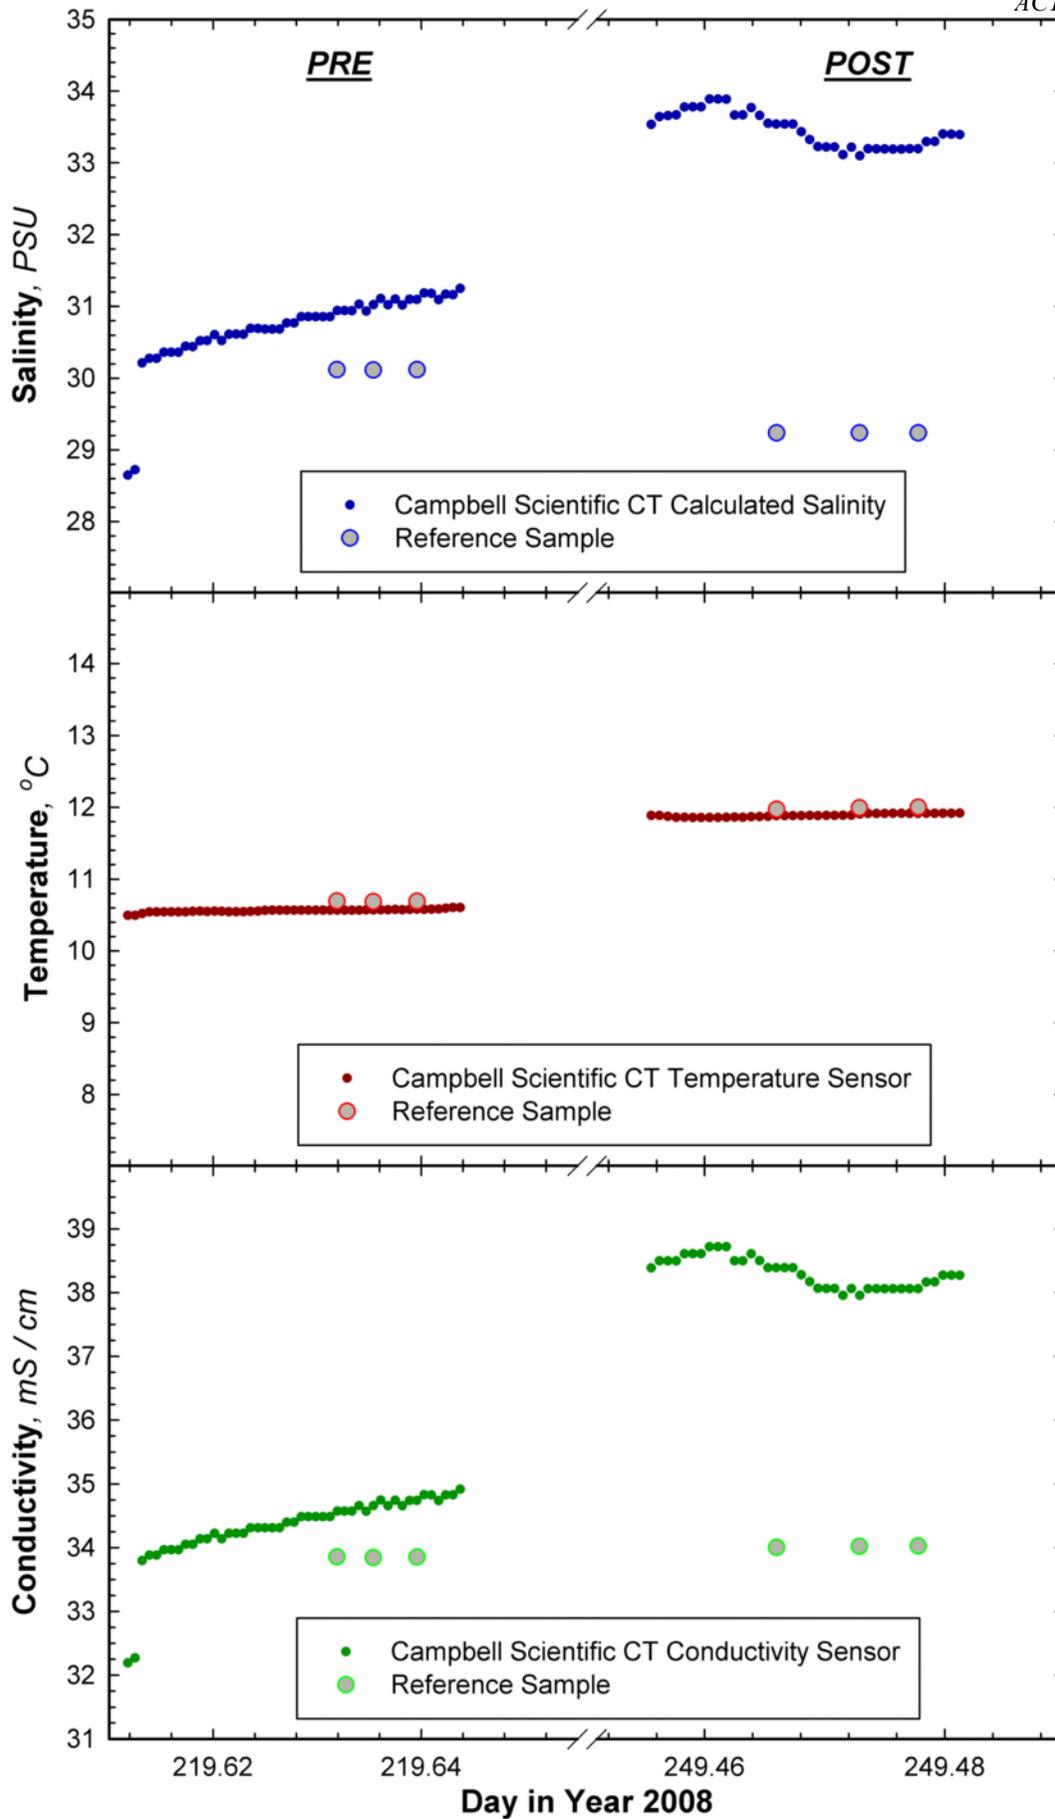
**Figure 33.** Pre- and Post-deployment reference checks in tanks of natural seawater at AK. Post-deployment tests conducted after cleaning instrument of all fouling material according to manufacturer's recommendations.

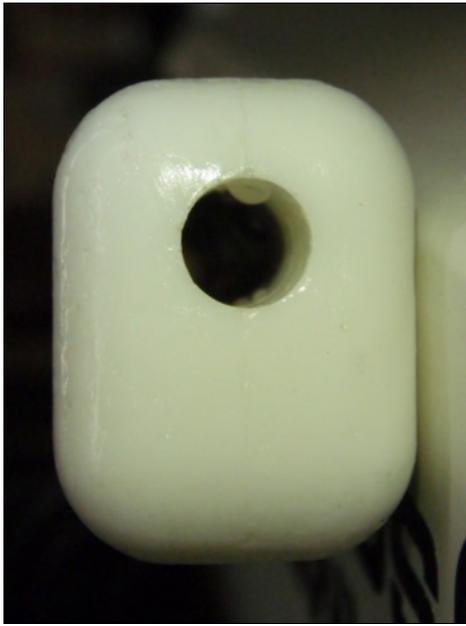
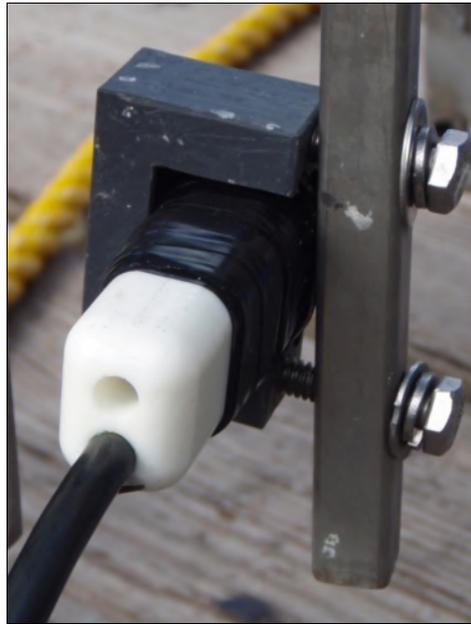
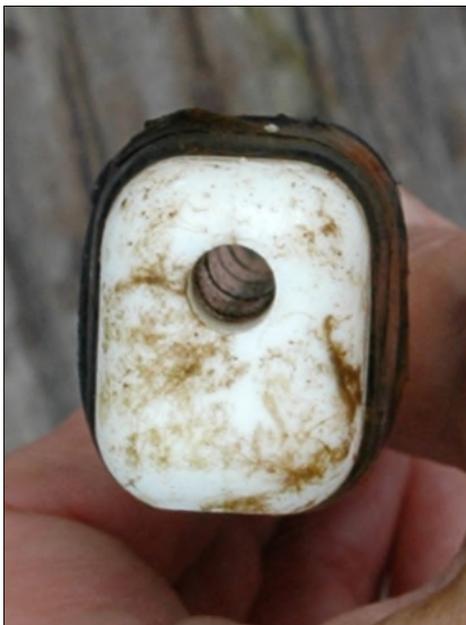
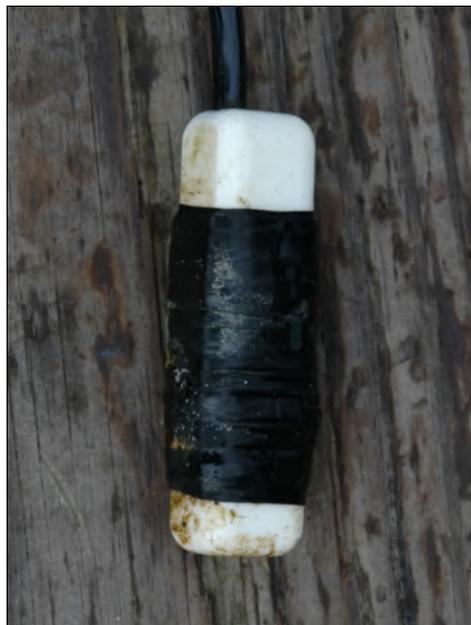
Before and after photos were taken of the instrument to examine the extent and possible impacts of bio-fouling (Fig. 34). The extent of bio-fouling at the AK test site was very small and the lowest of any of the five test sites. No hard fouling was observed.

Prior to Deployment (Close-up)

Prior to Deployment (Full View)

After Deployment (Close-up)

After Deployment (Full View)

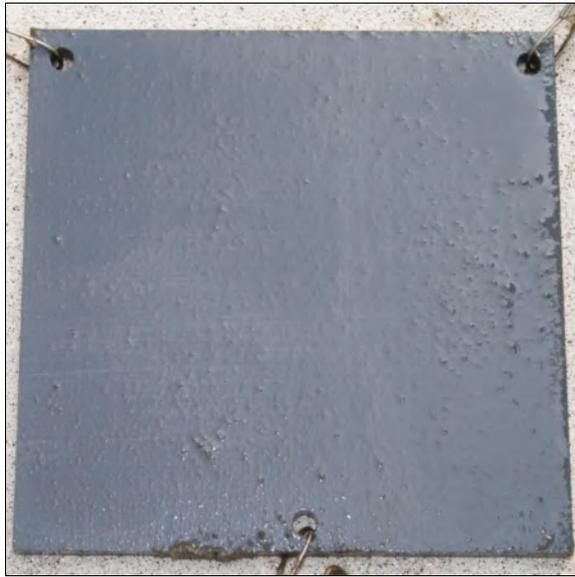
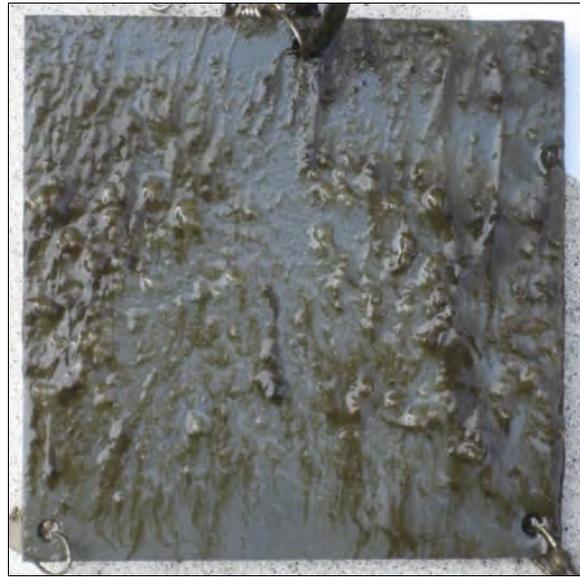
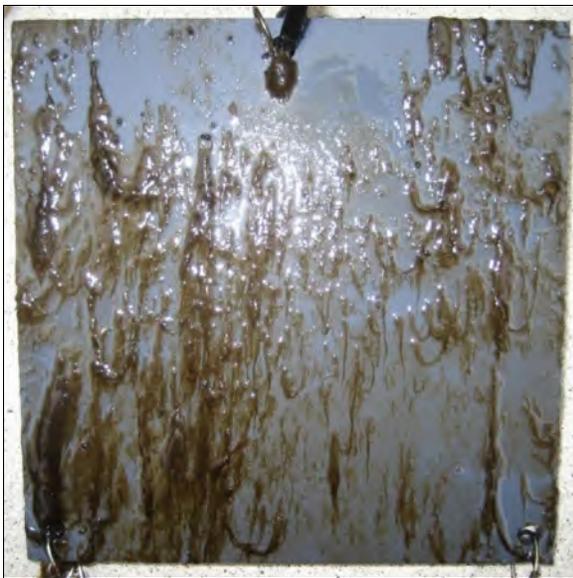
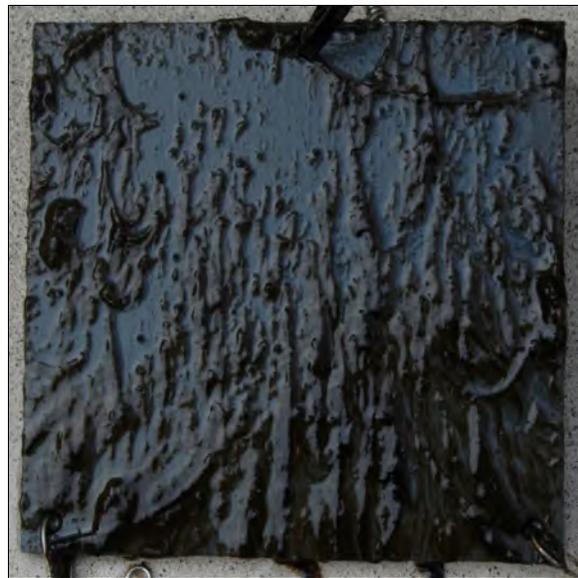
AK Site Week 1

AK Site Week 2

AK Site Week 3

AK Site Week 4

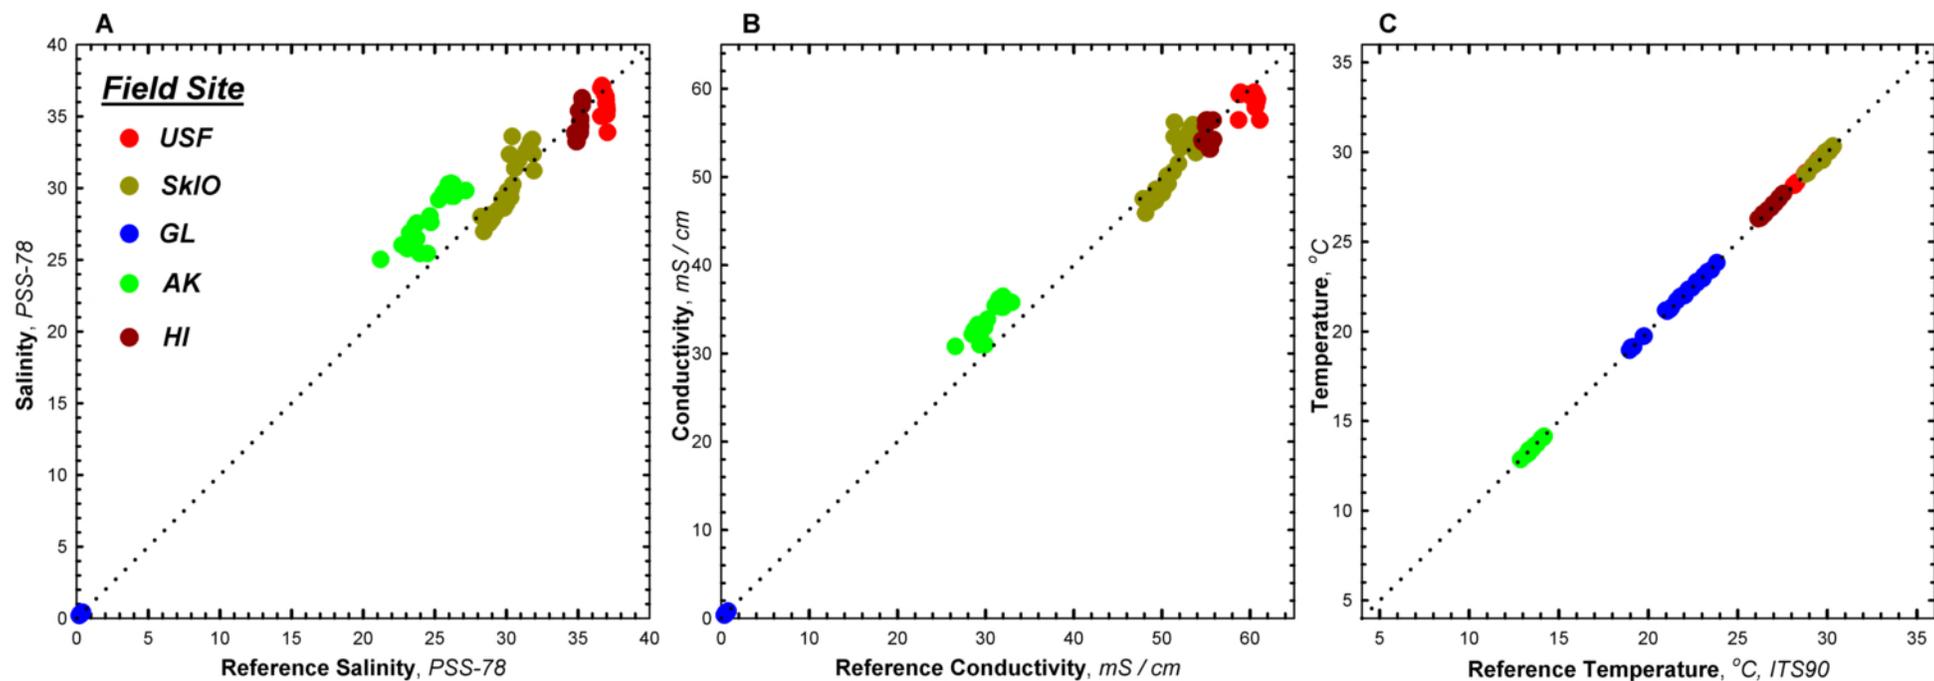
**Figure 36.** Composite summary of field performance over the first 14 days of deployment for the four Campbell Scientific CR8000 CT units tested during the five evaluation trials. Instrument output plotted against paired field reference sample assay and color indexed by field test site. Dotted line represents 1:1 data correspondence trend line. Scatter around trend line represents occurrence of site-specific fouling effects on conductivity cell performance.

Field deployment results were composited for all five test sites to provide an overall comparison of instrument performance across the range of environmental conditions present at out test sites. Data were restricted to the first 14 days of the deployments at each site to minimize the effects of biofouling. The data are analyzed by plotting in situ instrument measurements against reference sample measurements for salinity, conductivity, and temperature (Fig. 36). The responses of the test instruments were highly linear when analyzed across all sites. The regression for salinity had an  $R^2 = 0.982$  with a standard error of 1.79 psu, resulting from both differences in calibration factors between sites, as well as changes that occurred during the deployment at a given site. In general, pooling results across sites provides a similar evaluation of instrument performance as was determined from the range of salinity and temperature conditions used in the laboratory tests. The effects of calibration, biofouling, drift, and site heterogeneity can be viewed as the vertical deviations from the 1:1 data correspondence trend line. As previously noted, temperature measurements were significantly more stable than conductivity and less prone to calibration errors and biofouling impacts.

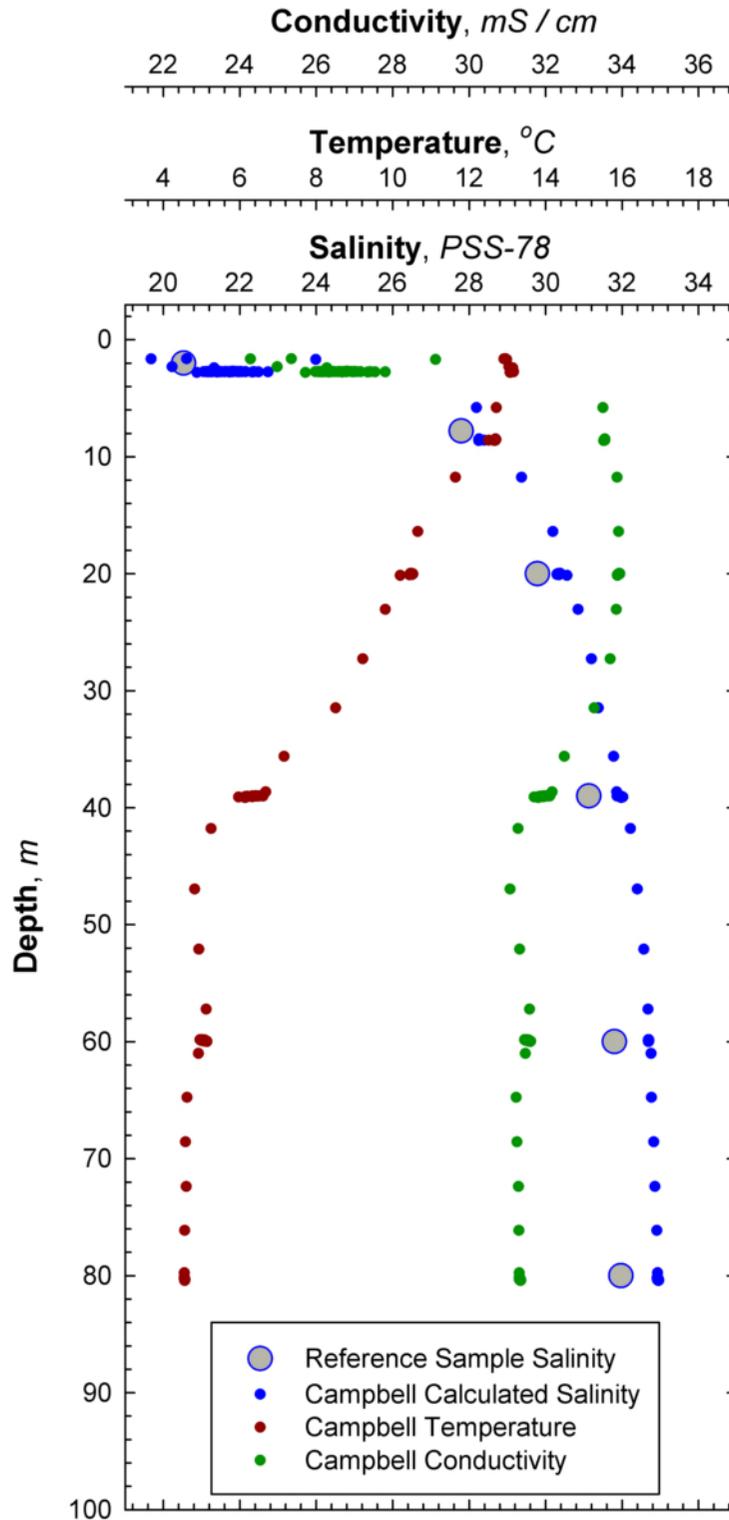
**Figure 37.** Vertical profile data from the Campbell Scientific CTD deployed offshore of the Seward Marine Life Center within Resurrection Bay, AK. Sharp pycnocline at 2 m indicative of influence of glacial runoff at this site.

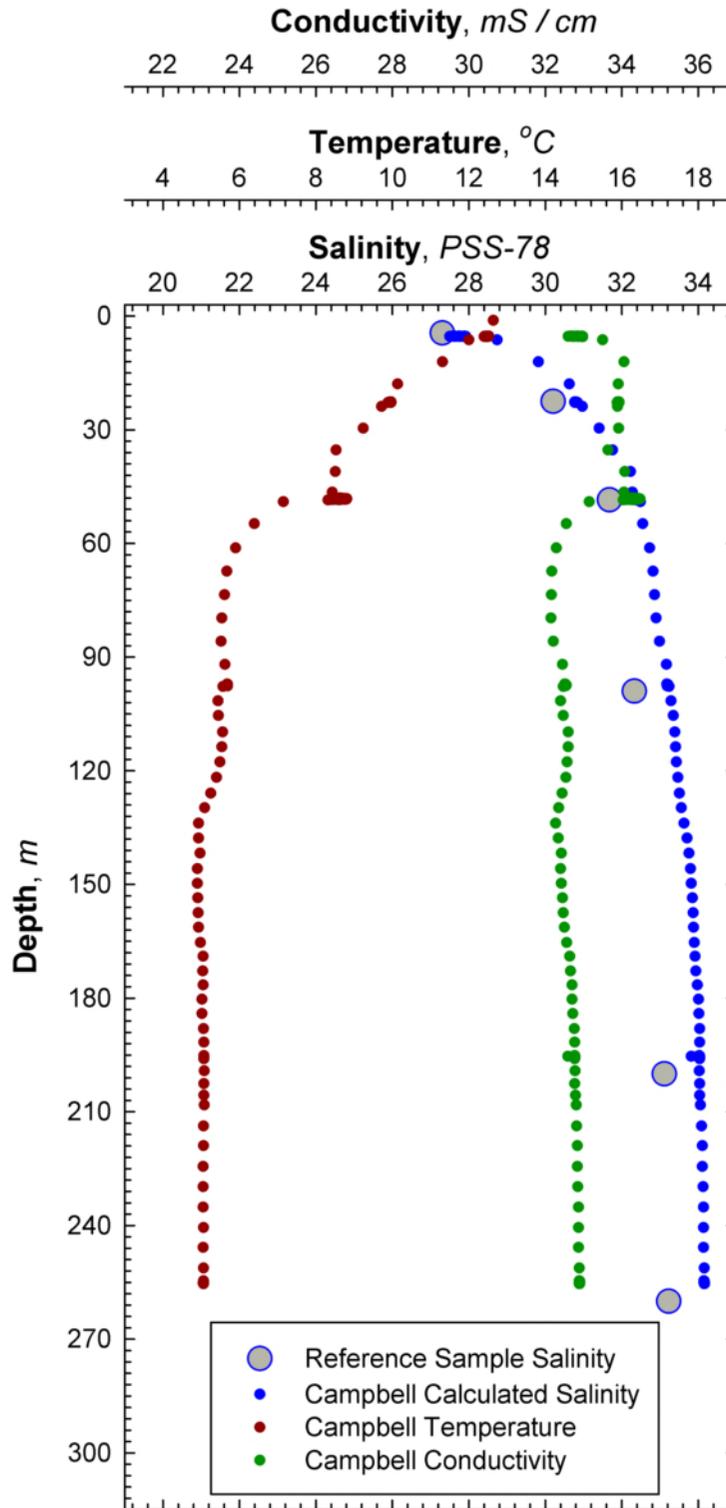
**Figure 38.** Vertical profile data from the Campbell Scientific CTD deployed in deep water off the shelf outside of Resurrection Bay, AK. Deeper and narrower pycnocline reflects mixing of offshore and bay waters.

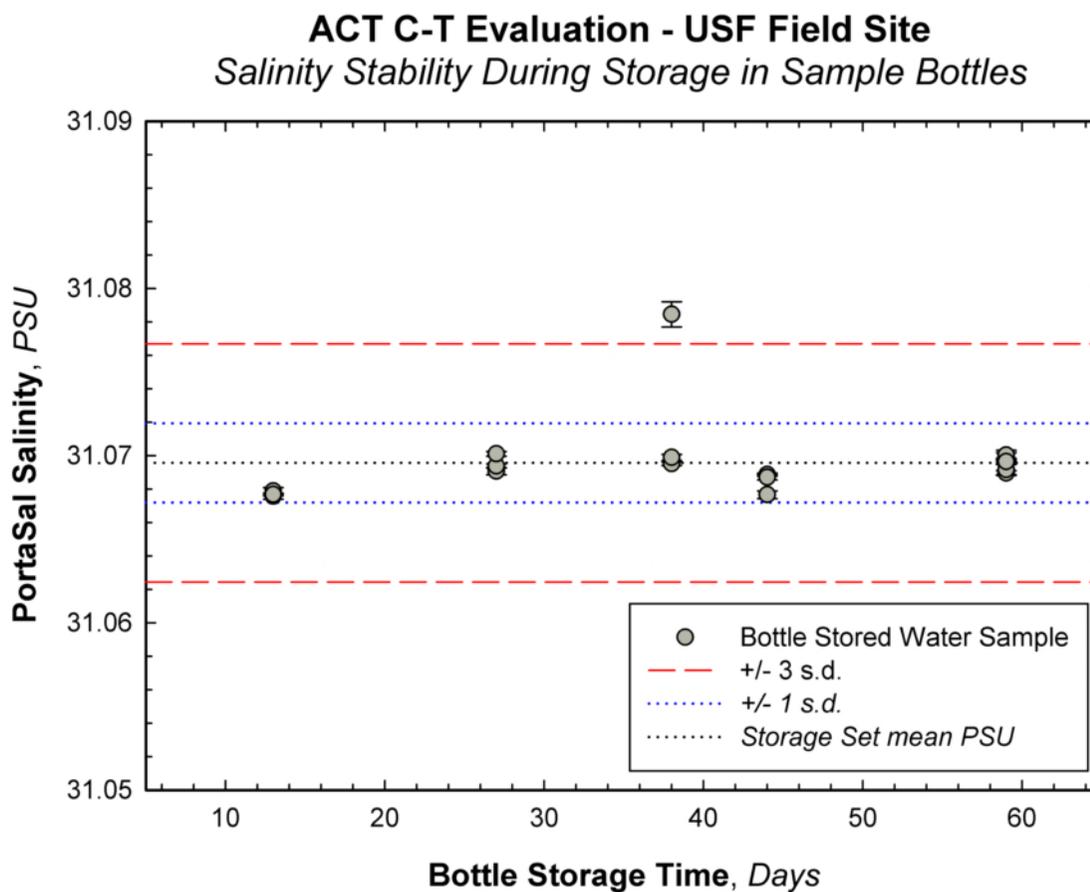
**Figure 39.** Assessment of drift in laboratory salinity measures associated with sample storage in field reference sample bottles. Sample bottles filled from single batch of test site surface water and subsets included in each sample shipment to MLML. Storage time reflects total time (days) since initial water collection.

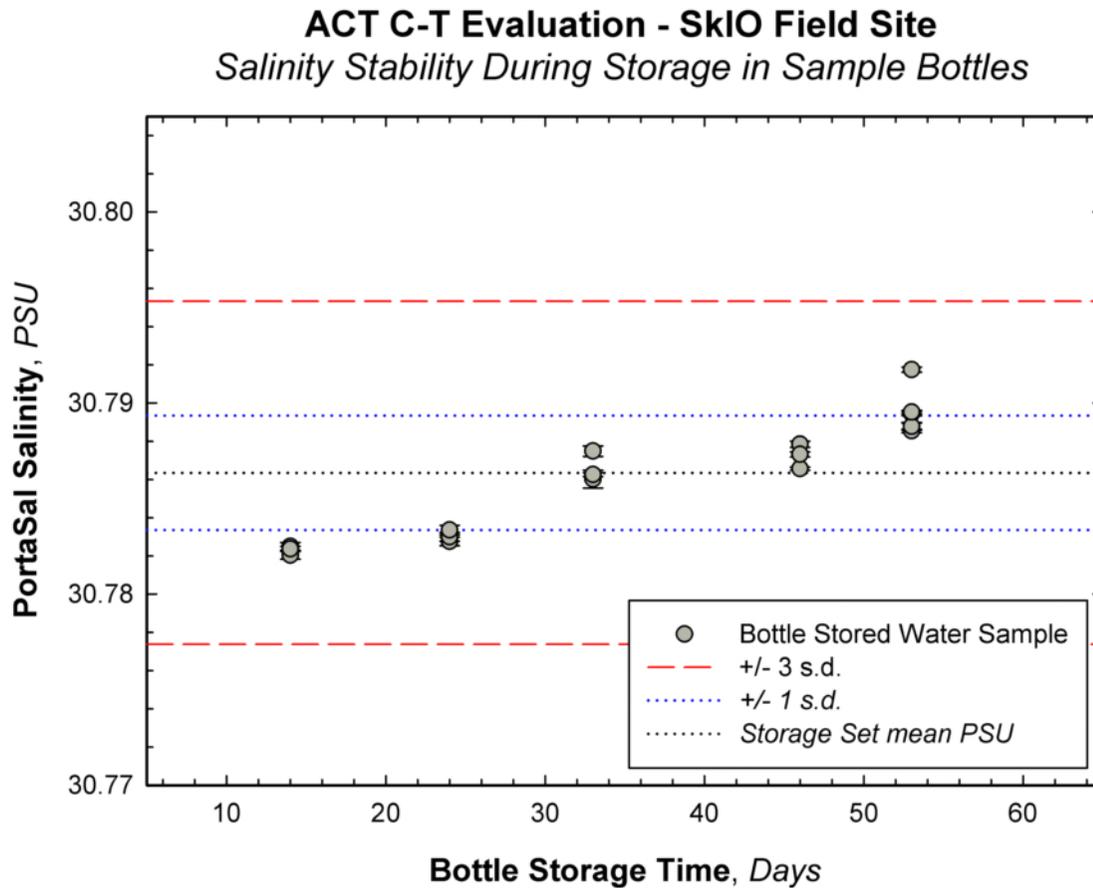
**Figure 40.** Assessment of drift in laboratory salinity measures associated with sample storage in field reference sample bottles. Sample bottles filled from single batch of test site surface water and subsets included in each sample shipment to MLML. Storage time reflects total time (days) since initial water collection.

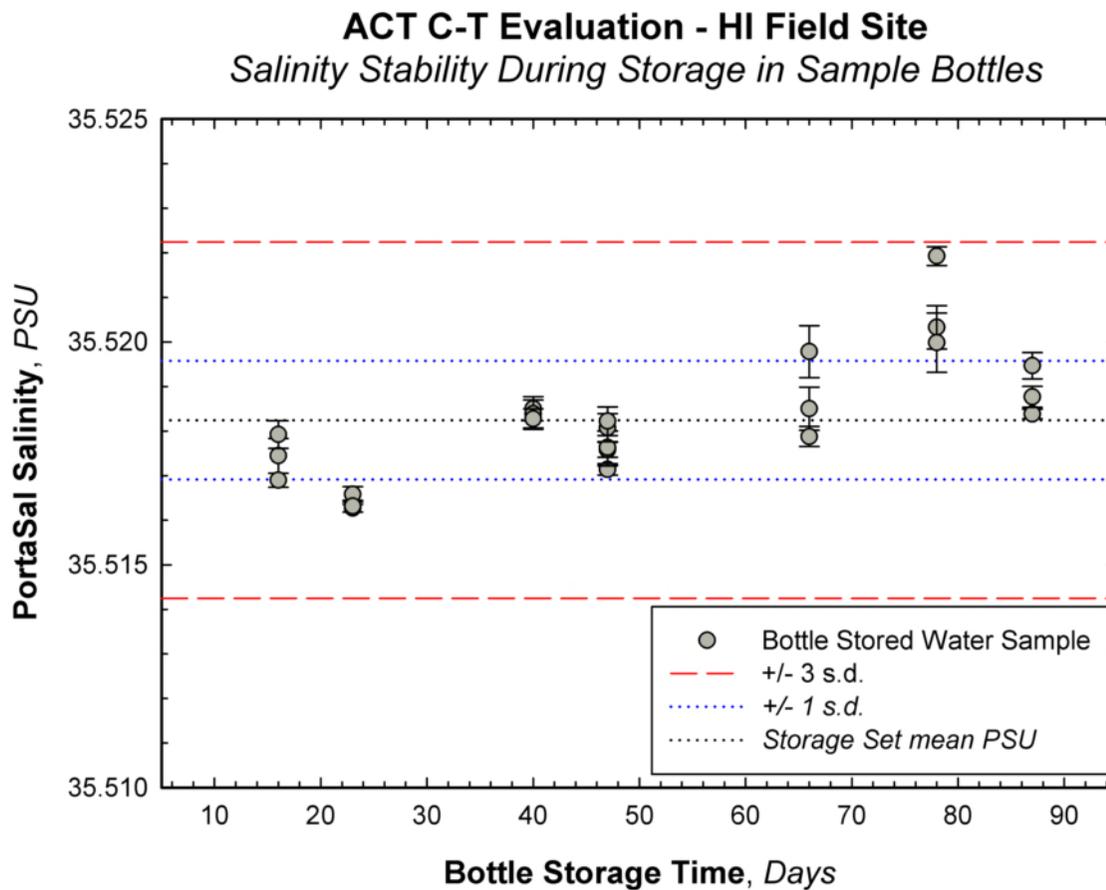
**Figure 41.** Assessment of drift in laboratory salinity measures associated with sample storage in field reference sample bottles. Sample bottles filled from single batch of test site surface water and subsets included in each sample shipment to MLML. Storage time reflects total time (days) since initial water collection.

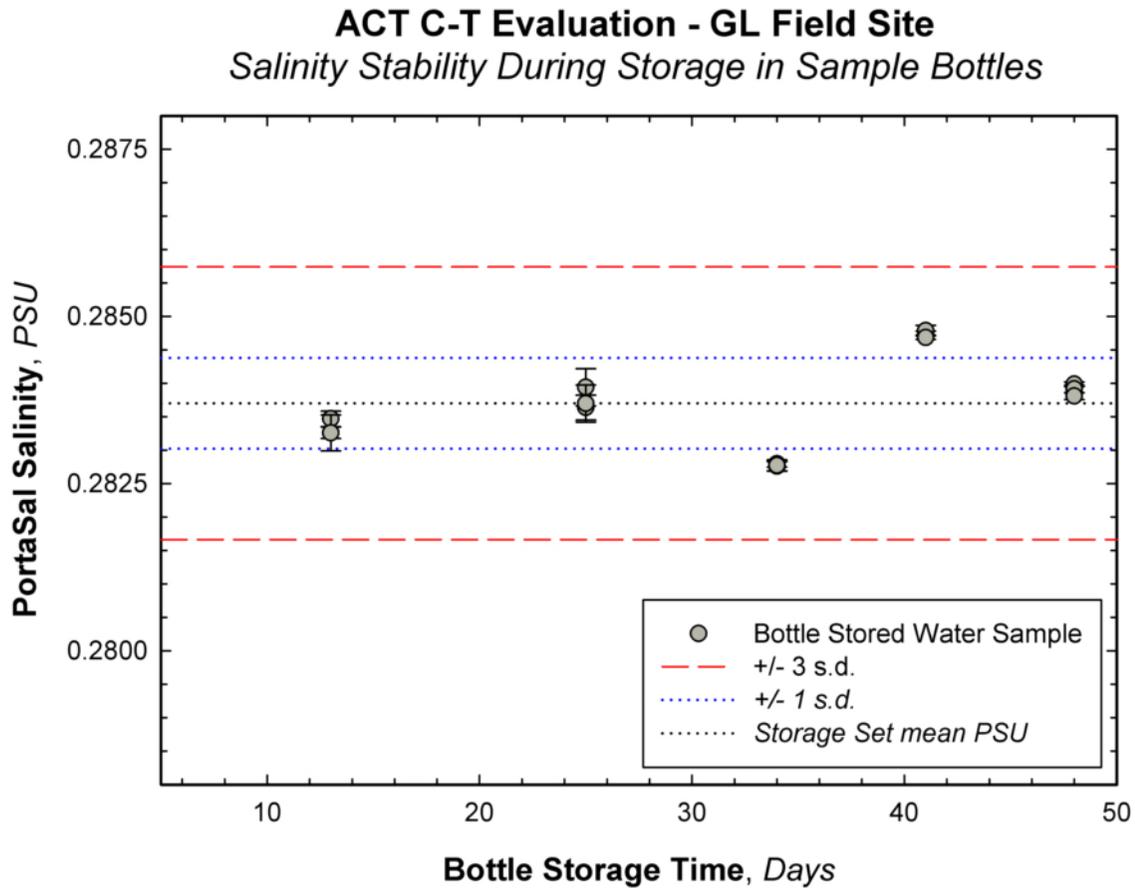
**Figure 42.** Assessment of drift in laboratory salinity measures associated with sample storage in field reference sample bottles. Sample bottles filled from single batch of test site surface water and subsets included in each sample shipment to MLML. Storage time reflects total time (days) since initial water collection.

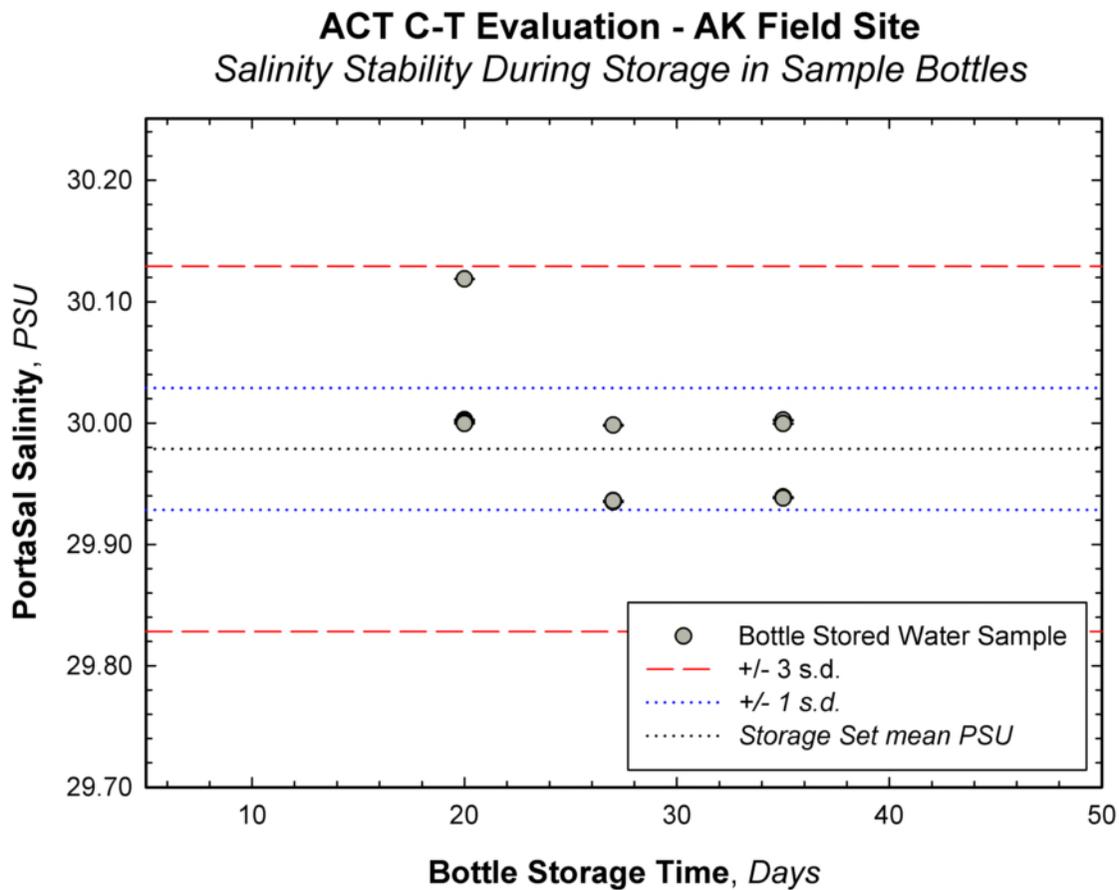
**Figure 43.** Assessment of drift in laboratory salinity measures associated with sample storage in field reference sample bottles. Sample bottles filled from single batch of test site surface water and subsets included in each sample shipment to MLML. Storage time reflects total time (days) since initial water collection.

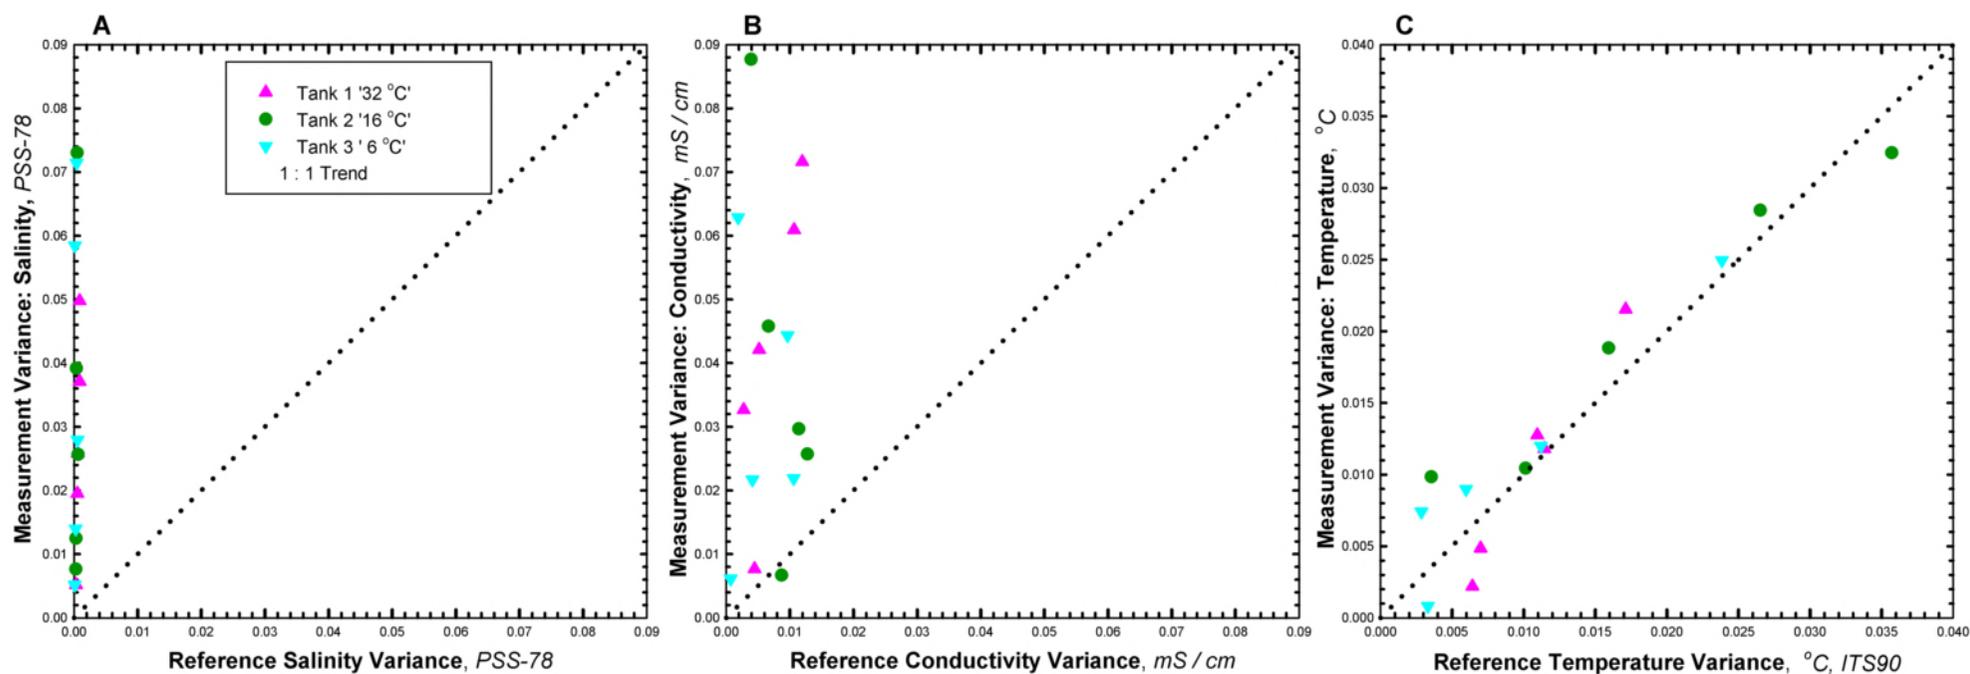
**Figure 4.** Evaluation of measurement variation of Campbell Scientific's model CR800 conductivity and temperature sensor package achieved during the laboratory exposure trials plotted in **Fig. 3**. Instrument measurement variance is presented as the standard deviation from 30 consecutive instrument reads recorded during the 30 min reference sampling for each test exposure and plotted against the corresponding variation in the reference measure. The 1:1 correspondence line (dotted) is provided for comparison, with points below the line indicating lower and above higher-instrument measurement variation than obtained by our reference methods and test conditions. [A] Co-variation of derived salinity estimates; [B] Co-variation of in situ conductivity measurements; [C] Co-variation of instrument temperature measurements.
